Condition Report

## ST. MICHAEL'S EPISCOPAL CHURCH

23 Main Street  
Geneseo, New York

OCTOBER 2020

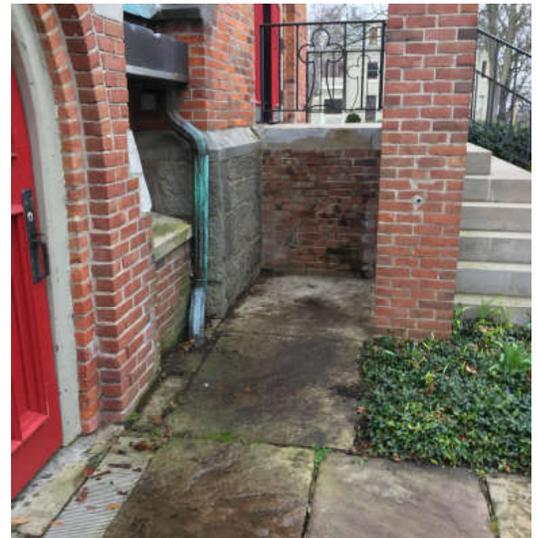
Existing grade at the Church's North Lower Entrance slopes toward the building along the stone sidewalk. There is a linear trench drain at the door's threshold and the brick recessed area (previously an accessible exterior vertical wheelchair lift location) has a floor drain. Both drains had vegetative debris potentially clogging the drain. We recommend re-grading the stone walk to pitch to a lowered swale between the east-west sidewalk and the North Lower Entrance door and providing an improved trench drain at this location.

Fig 14 - North Lower Entrance looking west

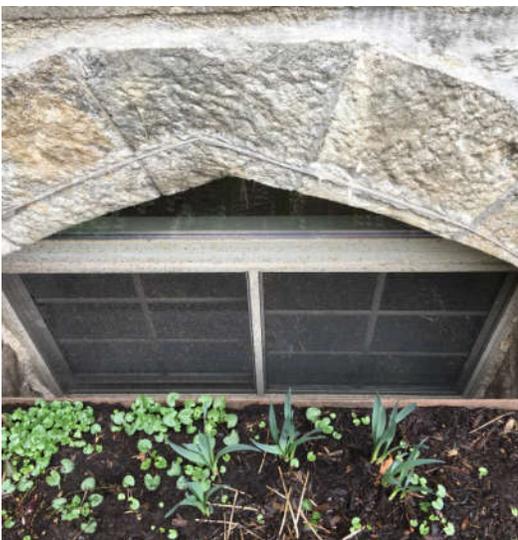
Based on observations, moisture appears to migrate through the porous masonry foundation walls, we recommend improving the window well conditions where feasible. Improvements include enlarging the size of the north window wells and modifying the existing window wells to allow for a minimum of 8" clearance from the window sill to base of the well. We recommend digging to 16" below the sills, installing a galvanized steel formed window well,

Fig 18 - North wall Basement window well

and placing 8” of granular material such as gravel or crushed stone in the bottom of each well so water will percolate down. Window wells shall be periodically maintained to ensure adequate drainage and removal of debris.

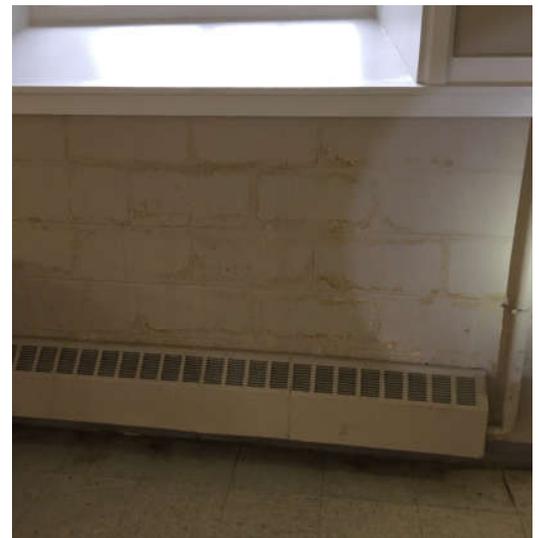
Fig 19 - Lower Hall moisture infiltration

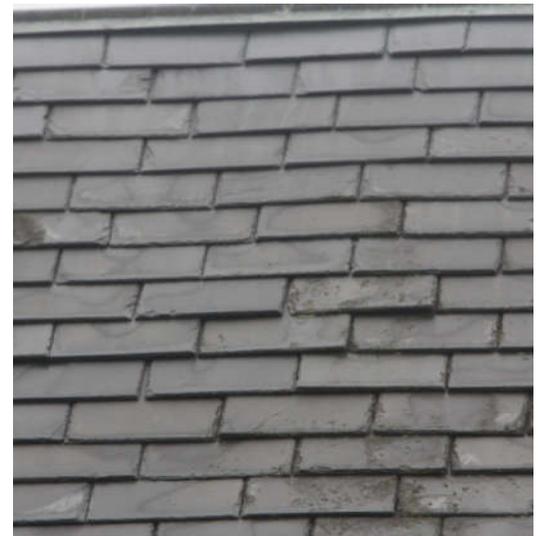
Because of the condition of your shingles annual maintenance is required. Each year a few slates will be lost to breakage or failed fasteners and must be replaced. *Attachment 6* provides detailed

Fig 26 - Condition of slate shingles

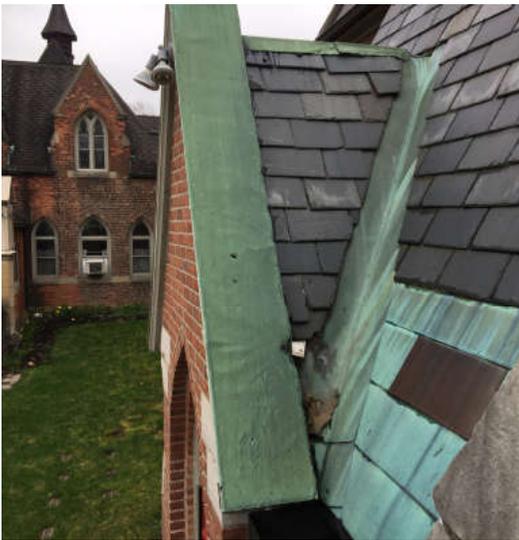
Proper flashing at the North Entrance roof area is complicated by the fact there are two cross gables and the Belfry tower. The ridge and valley flashings at the North Entrance are in poor condition and there are many loose or missing slate shingles. The Lower Entrance gable is covered in copper sheet metal coping in poor condition requiring replacement. In general the sheet metal fabrications at this area are

Fig 37 - North Lower Entrance ridge and, valley flashings

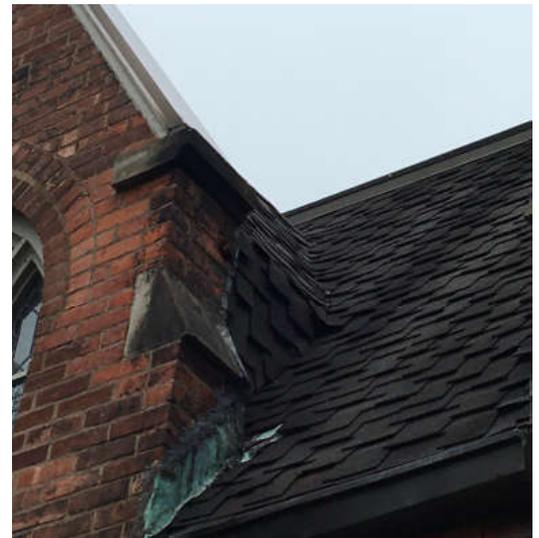
Fig 41 - Dormer flashings - West elevation

We recommend full dormer roofing and flashing replacement at the (2) East elevation gable parapet and (1) East elevation dormer, along with the adjacent dormers at the South and North. We recommend the coping be replaced, the roofing and sidewalls of the dormers be replaced with standing seam copper, and an open valley be provided at the dormer valleys to connect to the gutters. At the East elevation gable parapet, we recommend replacing the base and counterflashings and coping. The chimney flashings should also be replaced when access to these upper roof areas and a qualified sheet metal contractor is on-site.

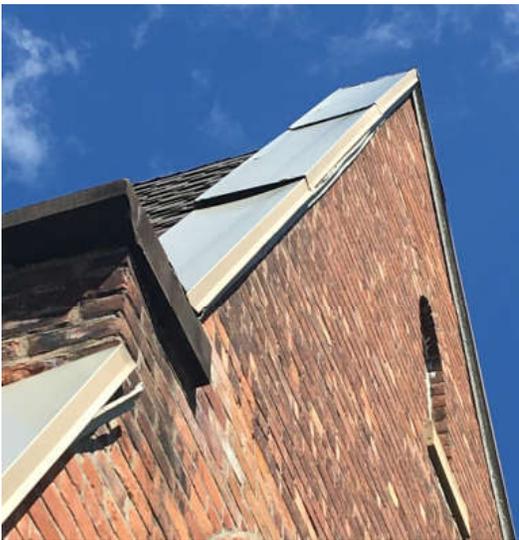
Fig 45 - East elevation gable coping

*Replace dormer roofing, sidewall flashings, copings, and valleys – (1) East + (1) South + (1) North and Replace East gable parapet base and counterflashings, and copings .....\$ 88,700 [E]*  
*Replace dormer roofing, sidewall flashings, copings, and valleys – (2) West + (1) South + (2) North.....\$ 64,400 [P]*  
*Replace chimney step flashing.....\$ 9,000 [P]*

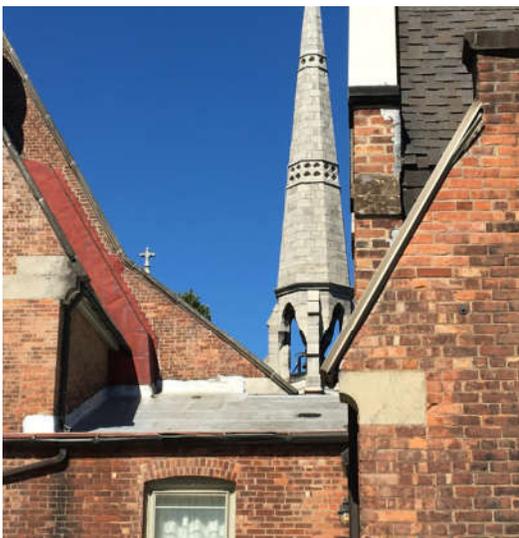
Fig 47 - Education Wing roofing

*Roof inspection, provide minor repairs, and re-coat.....\$ 4,300 [P]*

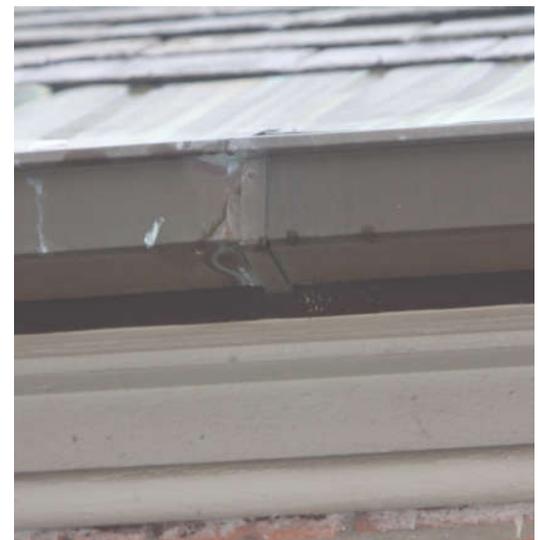
The gutters are bent and distorted in some areas potentially due to ice slides and inadequate allowance for temperature expansion and contraction. The south gutter needs an expansion joint at the middle to allow for proper movement as there appears to be a hole in a center joint that drips water. Gutters should be straightened and

Fig 57 - Gutter showing leaking

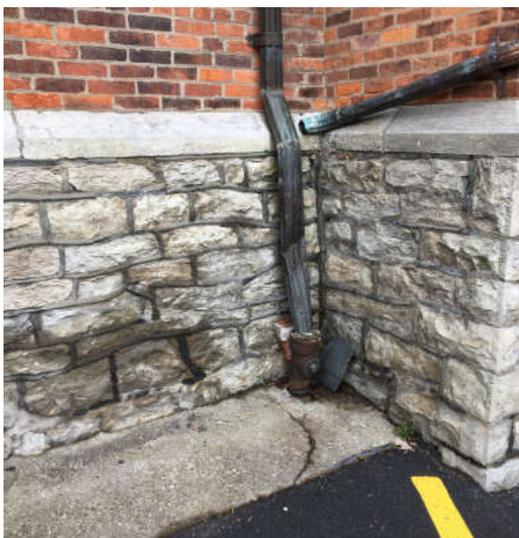
Fig 62 - East elevation - (2) downspouts to connect

- Provide expansion joint at center of north and south elevation gutter lengths .....\$ 16,300 [P]*
- Replace gutter at northeast valley of Lower Entrance .....\$ 2,700 [P]*
- Reconfigure and replace the gutter to downspout connection at the west side of South Transept .....\$ 13,800 [E]*

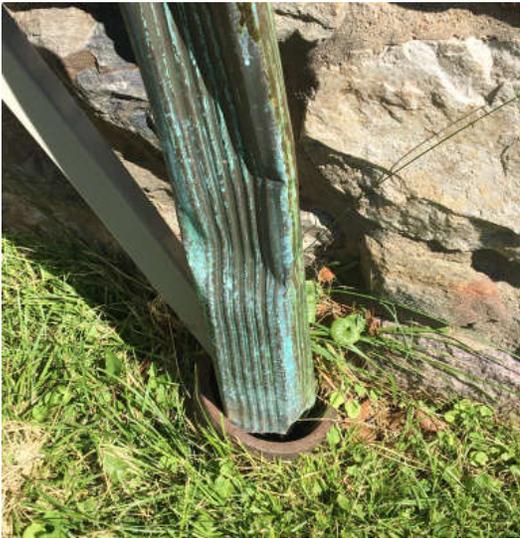
All downspouts except for one at the east elevation drain into hubs without cleanouts. We recommend you plan to install cleanouts at the hubs and straighten downspouts damaged by lawn equipment.

Fig 67 - Bent downspout

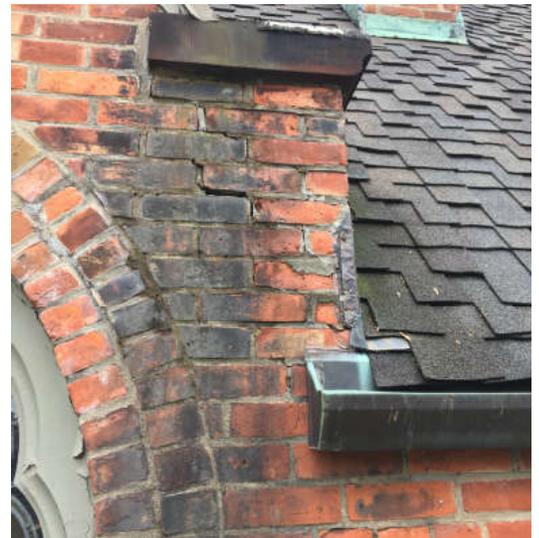
Fig 78 - Gable dormer deterioration

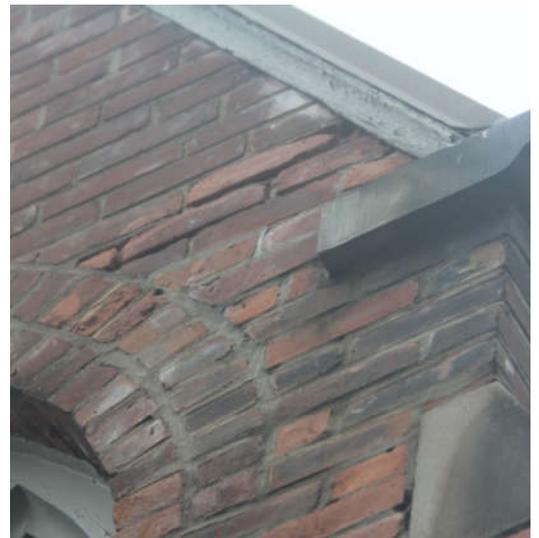
Fig 79 - Gable dormer deterioration

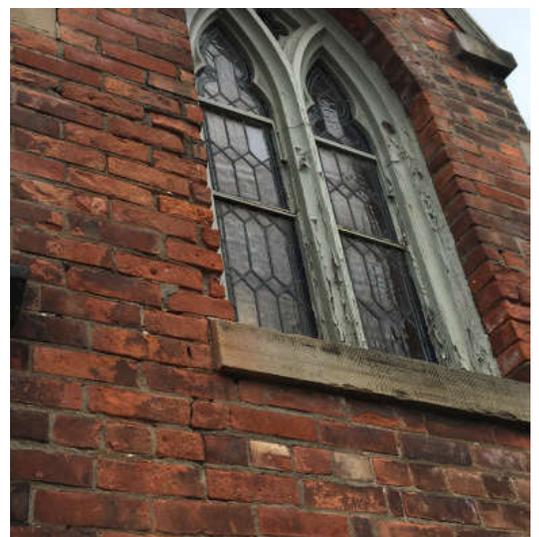
Fig 81 - Brick spalling at surrounds

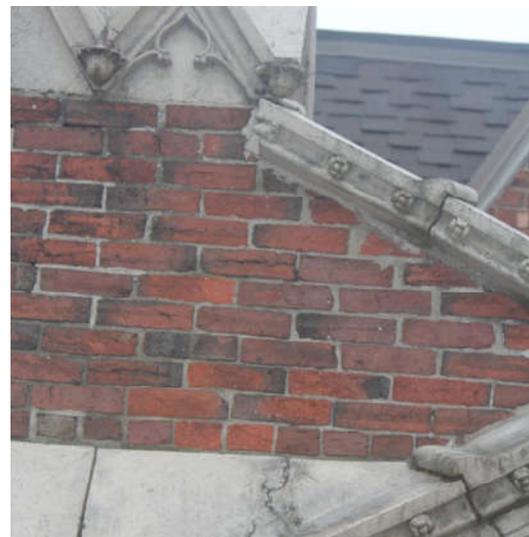
Fig 85 - Deterioration from coping to arch

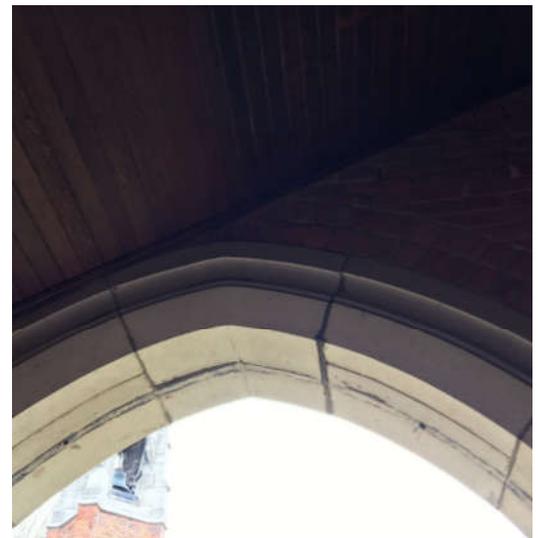
Fig 86 - Arch member movement

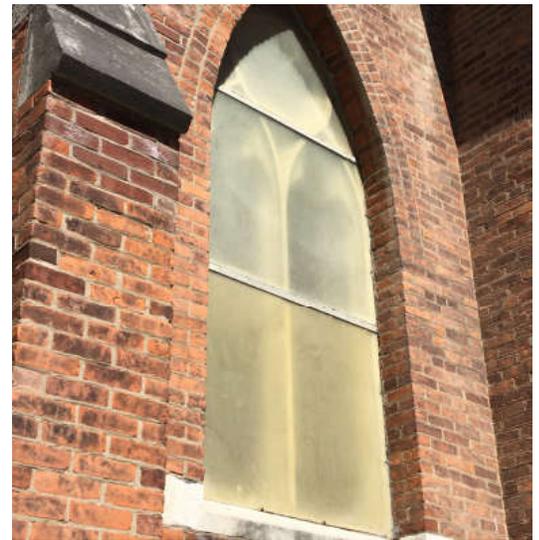
Protective panels are often installed over leaded glass to protect valuable windows from vandalism, to increase energy efficiency, or to protect the window from weather. Recent experience has revealed that installing protective glazing often creates a problem with setting up a micro-climate between the prime window and its protective panel. Overheating of the leaded glass caused by the greenhouse effect within the space is one of the primary reasons for deterioration and buckling of leaded glass comes. Condensation trapped between the leaded glass and the protective panel further deteriorates the window framing and lead comes. It has been found that in order to truly protect leaded glass, protective glazing must be well-ventilated, spaced appropriately away from the prime sash, and frequently inspected for problems at the framing that may be hidden by the panels.

Fig 102 - East elevation - Protective panel

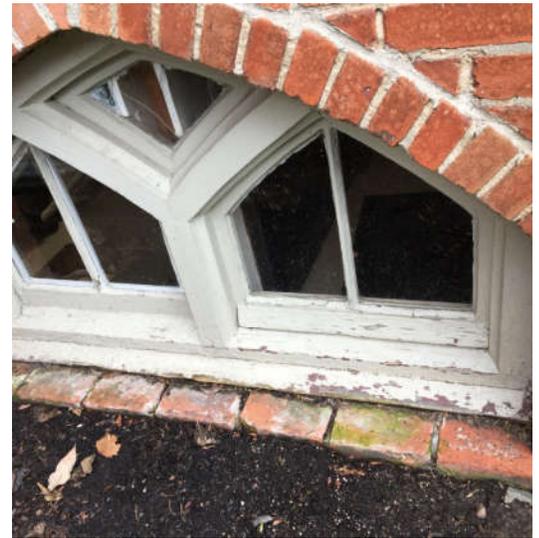
We noted only a few remaining wood windows potentially original to the buildings. There is one Church basement window on the north side and one wood window at the West Entrance to the Chapel. Both wood framing and sash require routine painting.

Fig 109 - Church basement wood window

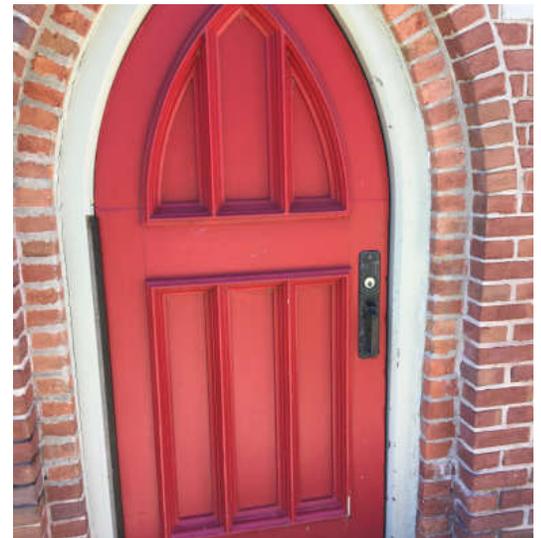
Fig 117 - Lower North Entrance door

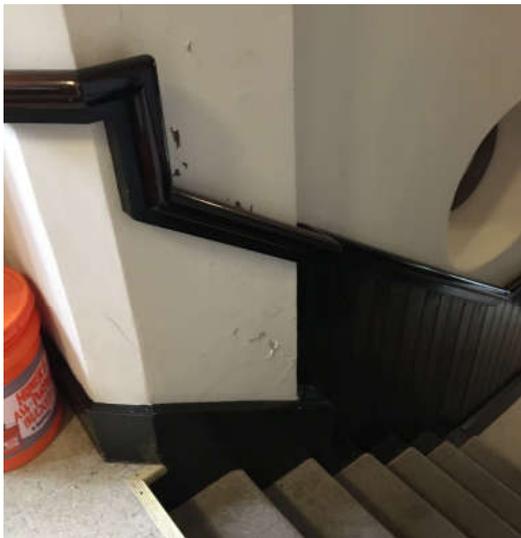
Fig 129 - North Entrance plaster damage

*Provide repairs to North Entrance interior stair plaster ceilings and walls ....*  
 .....\$ 4,300 [P]  
*Provide repairs to 2nd floor ceiling and walls in east office spaces .....*  
 .....\$ 5,300 [P]

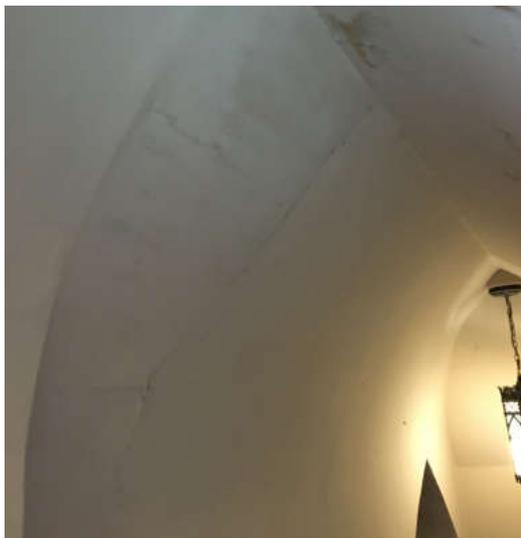
Fig 130 - Plaster damage

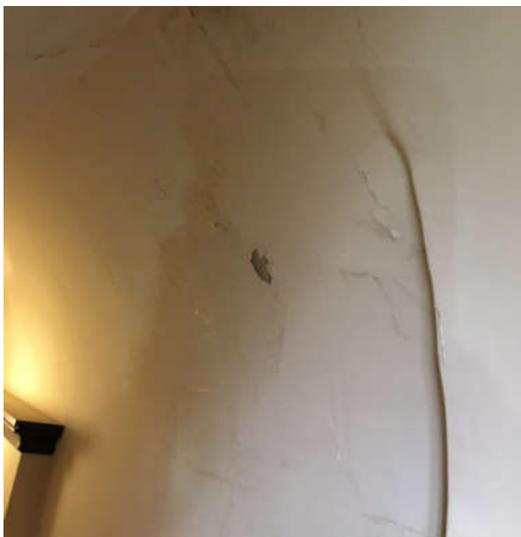
Fig 131 - Plaster damage

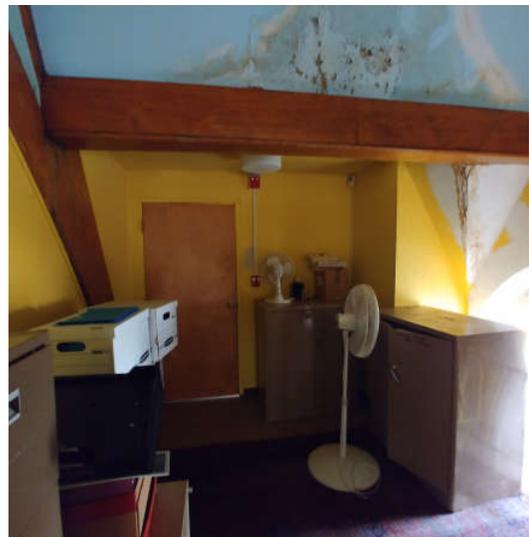
Fig 132 - 2nd floor Parish House damage

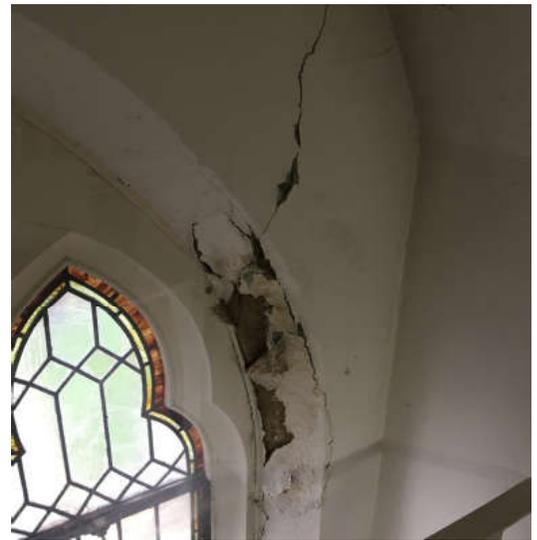
Fig 133 - Plaster damage

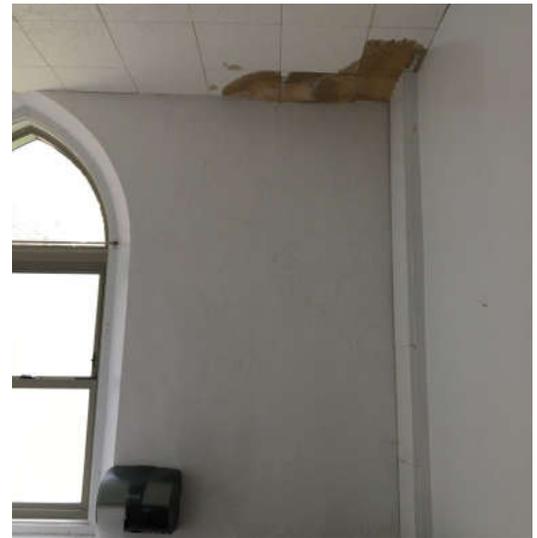
Stained and missing suspended ceiling tile in the Parish House and Church was noted on both the 1st floor and in the basement. The Church should maintain an attic stock of tiles and replace soiled tiles

Fig 134 - Ceiling tile damage

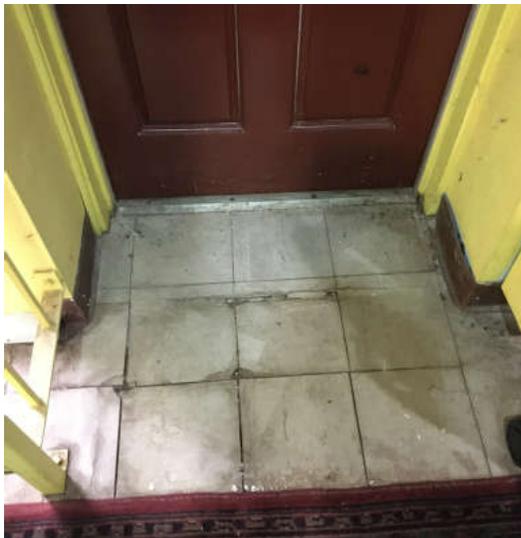
The Church's terrazzo flooring is cracking in locations. The terrazzo, a poured cementitious mix, is set on the 1st floor framing over the Basement Lower Hall. Cracking may be original to construction if an allowance for movement was not detailed appropriately in the installation. We noted several locations of cracking near entrance doors and have concern that cracking may be impacted by foot traffic

Fig 135 - Floor tile damage

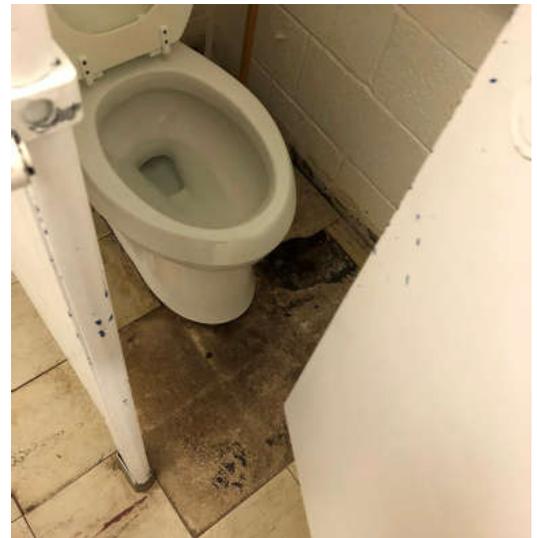
Fig 136 - Floor tile damage
