Condition Report

## ST. MICHAEL'S EPISCOPAL CHURCH

23 Main Street  
Geneseo, New York

OCTOBER 2020

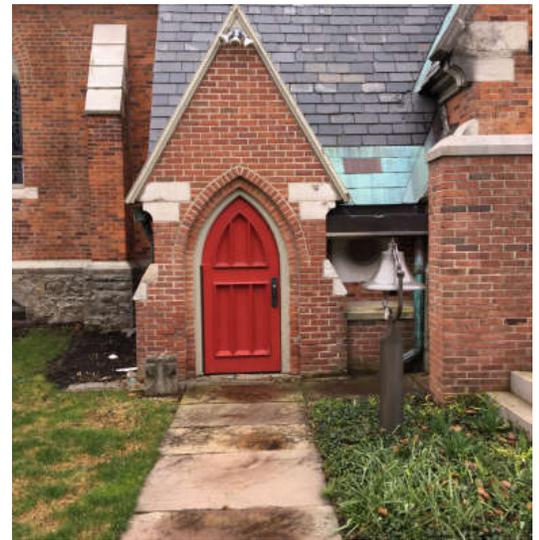
Fig 13 - North Lower Entrance

*Regrade at North Lower Entrance sidewalk and door. Provide improved trench drain.....\$ 8,000 [P]*  
*Improve grade at north wall of Chapel.....\$ 500 [P]*  
*Improve grade at all elevations as maintenance activity ..... Periodic maintenance*

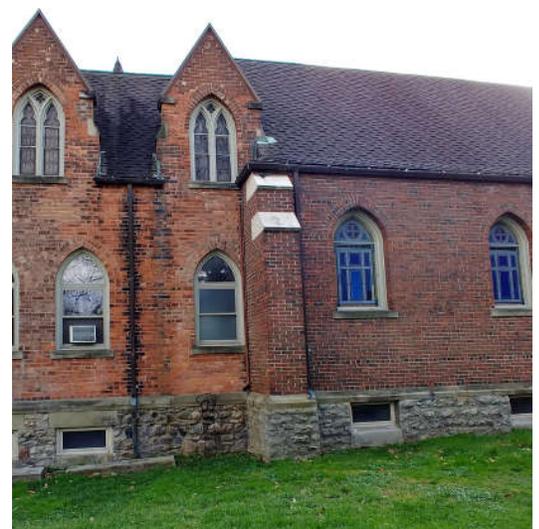
Existing grade at the north side of the Parish House is level to the eye with a small indented area adjacent to the base of the Chapel's east buttress. Water potentially ponds in this area based on wear in the grass area, and we recommend grade be improved.

Fig 15 - North wall of Chapel

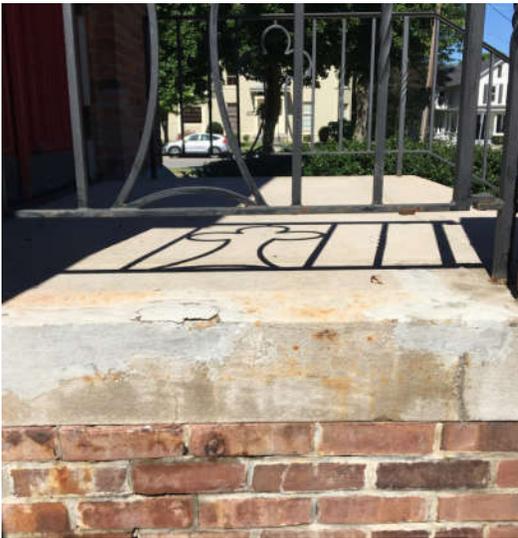
Fig 16 - North Entrance concrete landing

*Repair concrete spalling at North Entrance landing slab.....\$ 1,200 [P]*  
*Replace stone paver at Chapel West Entrance steps.....\$ 600 [P]*

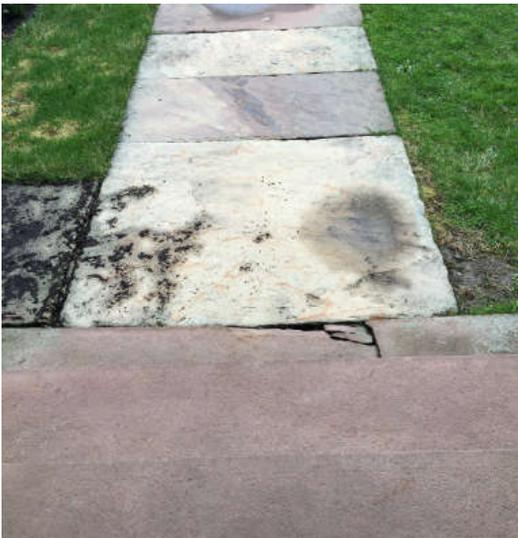
Fig 17 - Stone paver at West Entrance to Chapel

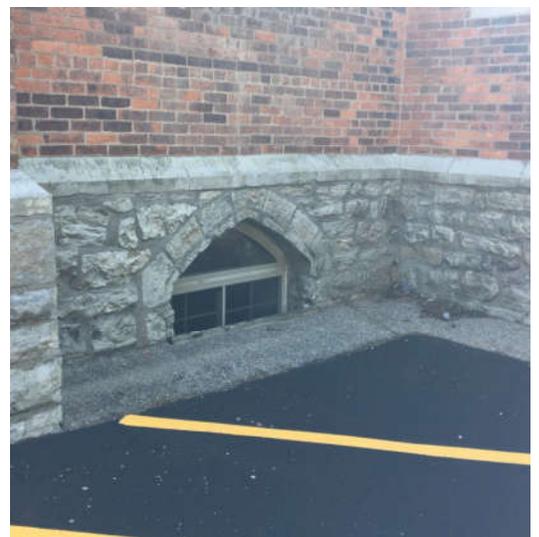
Fig 21 -South wall Basement window well

Correct grade. Divert surface runoff away from the foundation. Basement window sills shall be a minimum of 8” above finish grade.

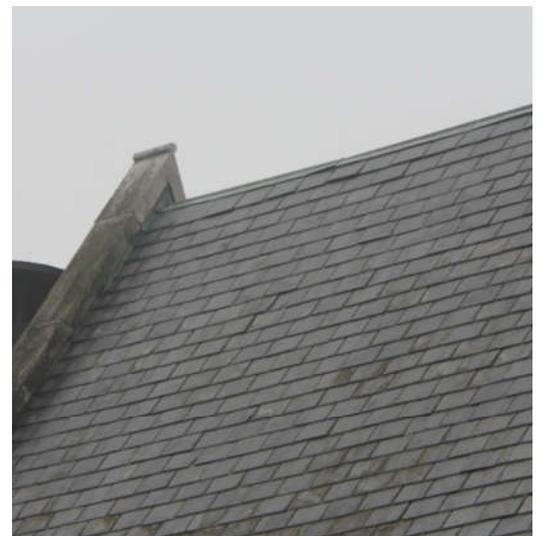
Slate durability depends on four factors: physical and mineralogical quality of slate, fabrication process of shingles, installation techniques, and regular and timely maintenance. Based on the assumed age of your shingles and their existing worn condition, we are suspecting your shingles are from the Lehigh-Northampton slate region of Pennsylvania. There is a gray/black shingle quarried in Pen Argyl, PA that historically is known to weather to a light brownish surface color and flake and delaminate in layers as it ages similar to the shingles of your roof. The brownish cast (rust or brown in tone) is due to oxidation of iron layered within the slate shingles. This type of slate is known to exude a chalky residue over time (whitish cast) as seen in your shingles. These shingles are not as hard and durable as other slates with an expected lifecycle span of only 50-75 years.

Fig 28 - North elevation slate shingles

We recommend you continue to have qualified contractors performing the required inspections and repairs to your building. Repairs and replaced shingles shall match the original in size, color, and thickness. For the estimate for annual repairs below, we assumed a crew of two men for two days with a lift. This is a recurring, annual expense. Attachment 7 describes appropriate slate roofing repair procedures.

*Annual slate roofing inspection and repairs.....\$ 9,400 [E]*

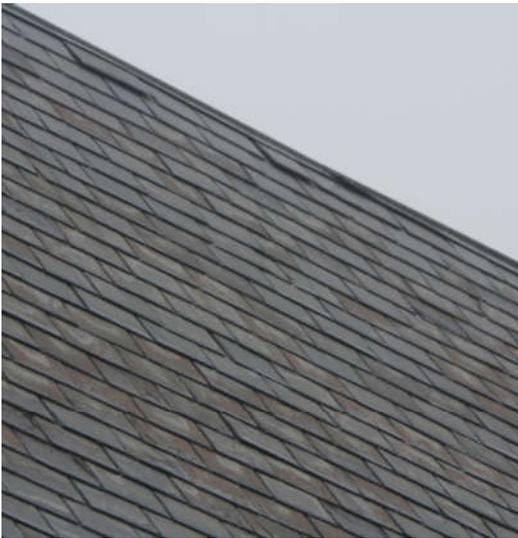
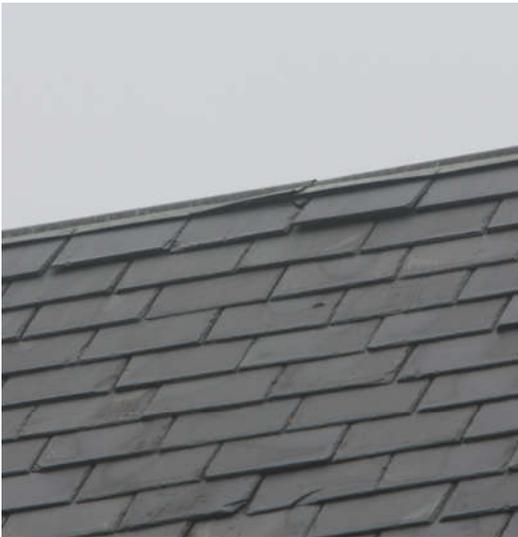
Fig 29 - Ridge flashings

covered in a sheet metal ridge roll. We noted areas along the ridge where slates are not laid flat, are loose or cracked, or have slid, and areas where the ridge roll is coming loose and bending upward. The ridge shingles at the North Entrance roofs are constructed of lapped sheet metal without the roll and formed drips found at the upper ridge metal; these flashings are in poor condition and we are concerned they are a contributing factor to the apparent water damage to the North Entrance interior plaster surfaces.

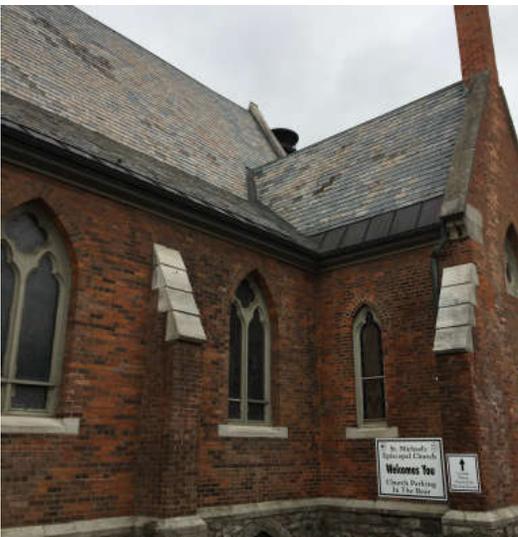
Fig 31 - South Transept valley

Valley flashings collect and move water down the roof surface to gutters. You have two main valleys at the South Transept Church roof and multiple valleys at the Belfry and North Entrance roof areas. Valleys, particularly at the North Entrance, have loose, cracked, and missing slates. Slate shingles require two fasteners per shingle and due to the configuration of the valley with many shingles being cut for the open valley flashing, the risk of inadequate fastening is increased. We recommend all valleys be regularly maintained. Each side of the South Transept, because of the volume of water collected, have issues requiring repairs, refer to Section 5, **MASONRY** and Section 7, **CARPENTRY**. The Transept sheet metal valleys and eave flashings appear to be more recently installed and well executed, but issues remain that relate to the adjacent, but connected building systems. The South Transept gable end is capped with a brick masonry chimney with failing sheet metal flashings that require replacement including re-laying the adjacent impacted shifting slate shingles.

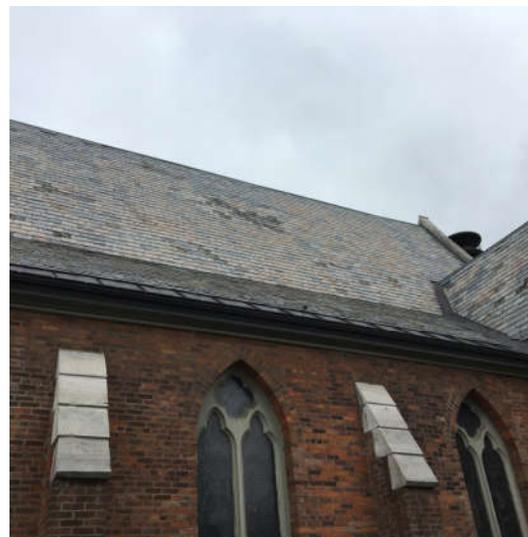
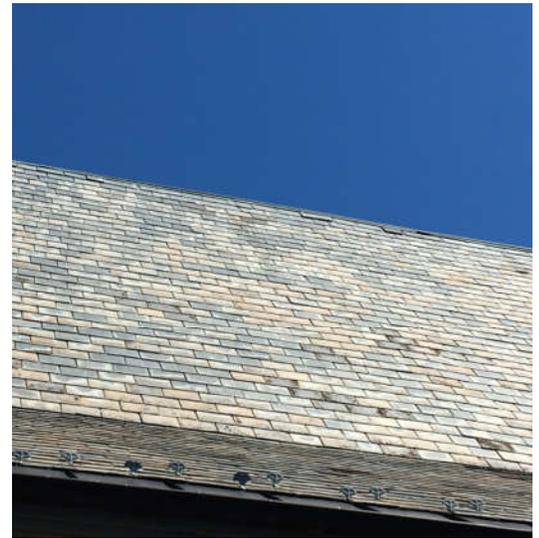
The main roof of the Church is a sloped gable structure that changes pitch at the side aisles. The slope of the roof impacts the longevity of the shingles as water moves faster along the steeper slope and when the pitch is reduced, water flow is more likely to be disrupted and snow build-up or ice dams are likely to form. Both the north and south aisle eaves have standing seam copper snowslides. Based on what appears to be recently installed sheet metal copper snowslides and snow guards along the south elevation, we suspect that ice damming is an issue. Snow and ice sliding off the roof can be dangerous and damaging and of a particular concern at the south elevation driveway location.

Fig 32 - Slope change at aisles

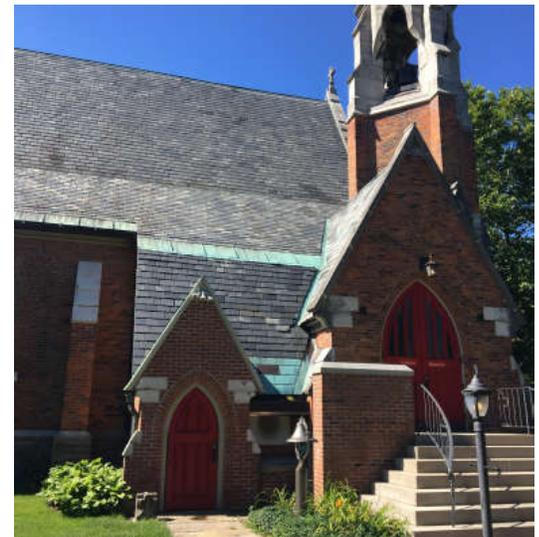
Fig 34 - North Entrance

Proper flashing at the North Entrance roof area is complicated by the fact there are two cross gables and the Belfry tower. The ridge and valley flashings at the North Entrance are in poor condition and there are many loose or missing slate shingles. The Lower Entrance gable is covered in copper sheet metal coping in poor condition requiring replacement. In general the sheet metal fabrications at this area are

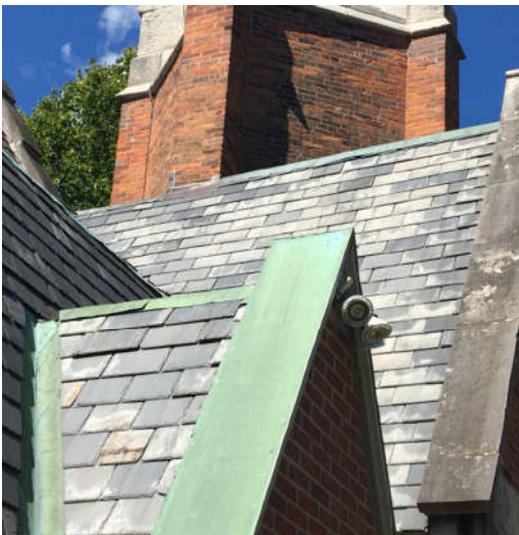
Fig 35 - North Entrance ridge flashings

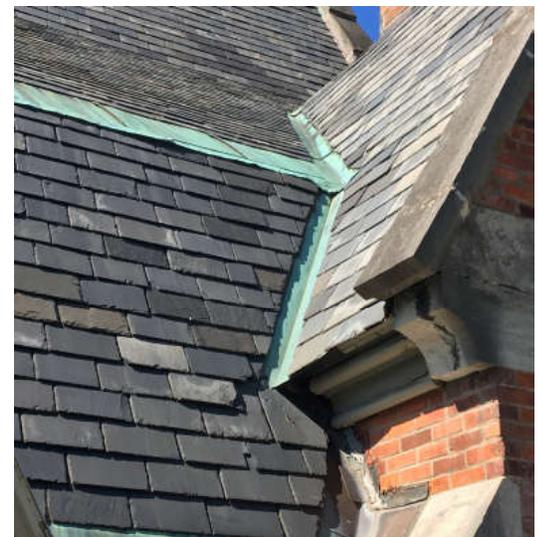
Fig 36 - North Entrance valley flashings

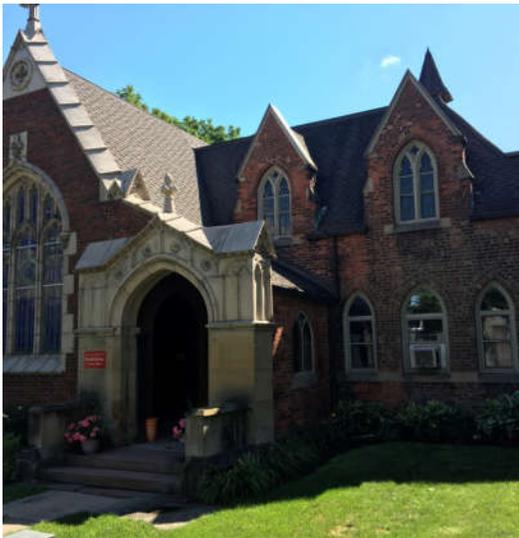
Fig 38 - West elevation

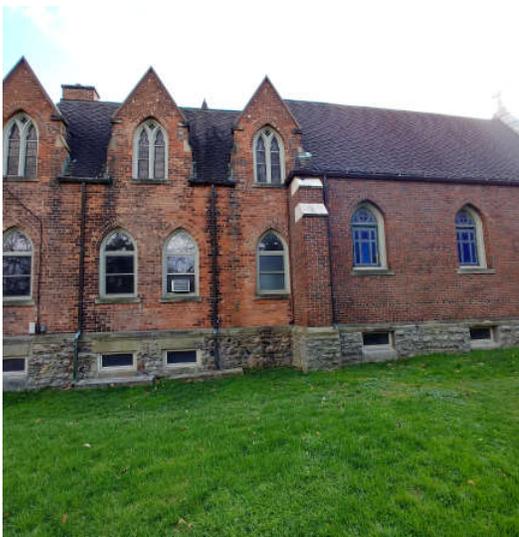
Fig 39 - North elevation

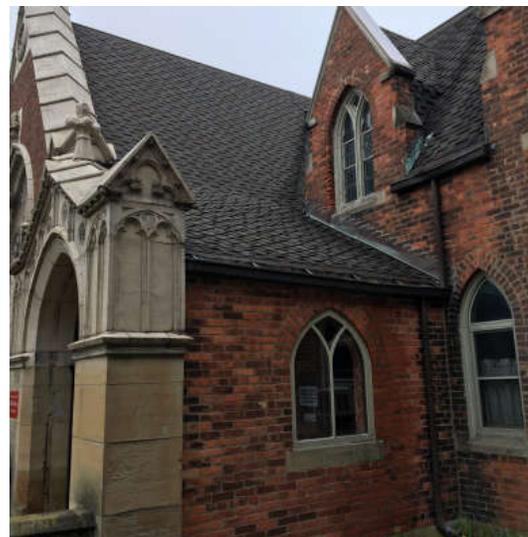
Fig 40 - West Entrance roofing

We assume that when the asphalt shingles were installed, the original flashings remained in place – except at the west wall of the Parish House over the West Entrance. The flashings are failing; they are covered in tar and sealant, and there are some exposed, rusting fasteners. We noted the poor condition of the flashings at the dormers and significant movement in masonry parapets of the dormers, refer to Section 5, **MASONRY**.

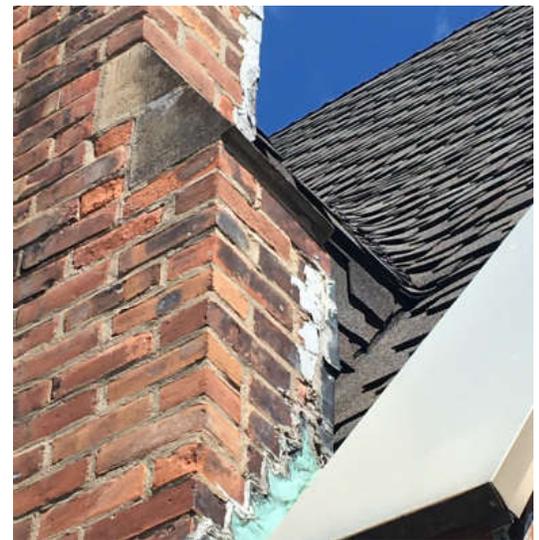
Fig 42 - Dormer flashings - South elevation

We recommend full dormer roofing and flashing replacement at the (2) East elevation gable parapet and (1) East elevation dormer, along with the adjacent dormers at the South and North. We recommend the coping be replaced, the roofing and sidewalls of the dormers be replaced with standing seam copper, and an open valley be provided at the dormer valleys to connect to the gutters. At the East elevation gable parapet, we recommend replacing the base and counterflashings and coping. The chimney flashings should also be replaced when access to these upper roof areas and a qualified sheet metal contractor is on-site.

*Replace dormer roofing, sidewall flashings, copings, and valleys – (1) East + (1) South + (1) North and Replace East gable parapet base and counterflashings, and copings .....\$ 88,700 [E]*  
*Replace dormer roofing, sidewall flashings, copings, and valleys – (2) West + (1) South + (2) North.....\$ 64,400 [P]*  
*Replace chimney step flashing.....\$ 9,000 [P]*

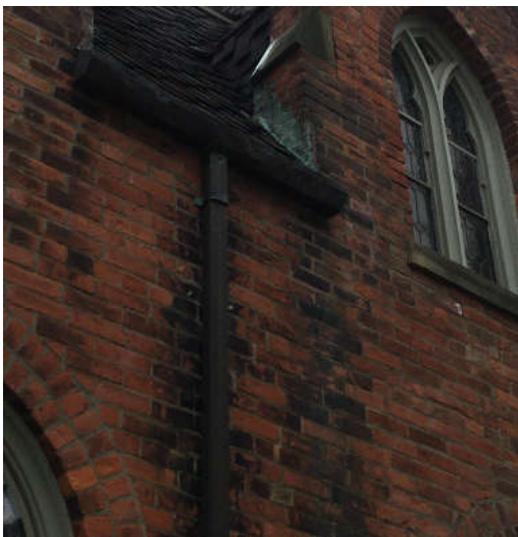
Fig 43 - Dormer flashings - North elevation

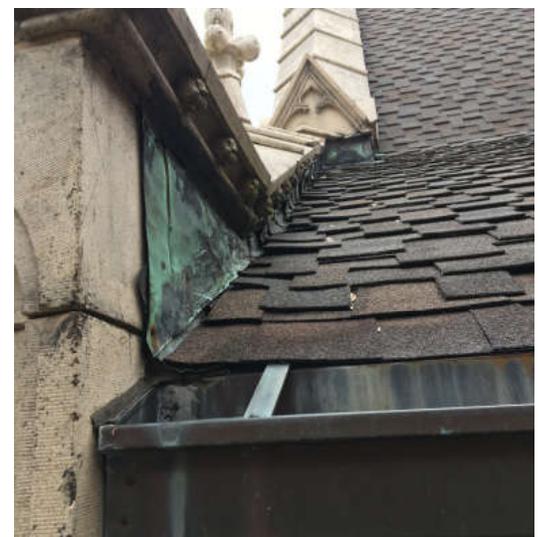
Fig 44 - Flashing at West Entrance coping

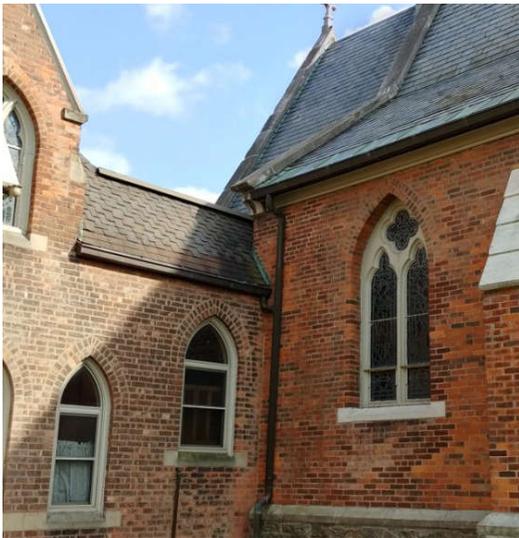
In configuration, the Chapel roof is a simple gable and the Parish House roof is part gable and part sloped mansard, both interrupted by multiple brick gable dormers along the eaves. It's configuration - with multiple roof intersections, parapets, and dormers, along with what we assume is inadequate roof insulation and attic ventilation - makes us suspicious that water issues from ice damming and snow collecting may be reoccurring problems. We noted many areas of bent gutters, indicating ice damming and snow slides. We observed that asphalt shingles were replaced along the west elevation of the Education Wing and we are assuming this was done when the gutter

was repaired or replaced. This repair is another clue to potential ice damming issues.

Fig 46 - Replaced shingles at gutter

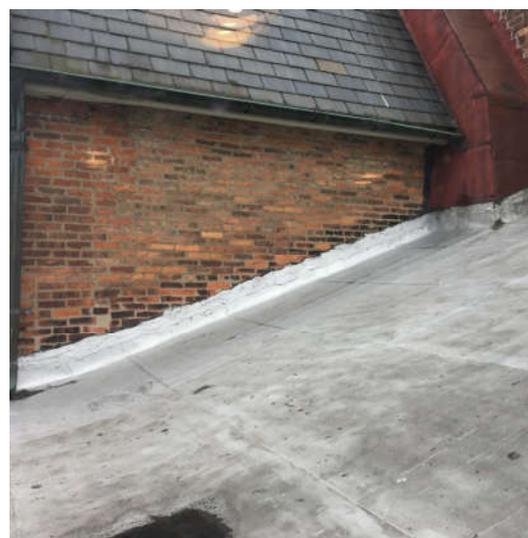
The Education Wing roof is covered with a modified bitumen low-slope membrane roofing. The roofing membrane, a built-up bitumen membrane appears to be in fair condition. It has been coated with a reflective aluminum coating that extends its service life by reducing the membrane's surface temperature and protecting the membrane from UV radiation and degradation. Coatings are inexpensive, but need to be refreshed frequently, as often as once every 3 years.

Fig 48 - Education Wing looking south

*Roof inspection, provide minor repairs, and re-coat.....\$ 4,300 [P]*

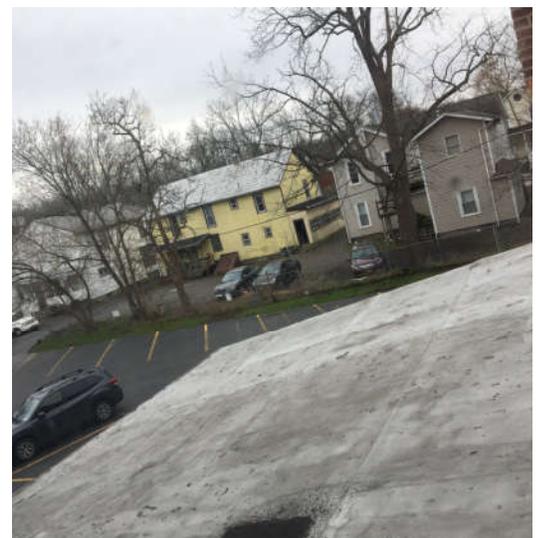
Fig 49 - Education Wing looking southeast

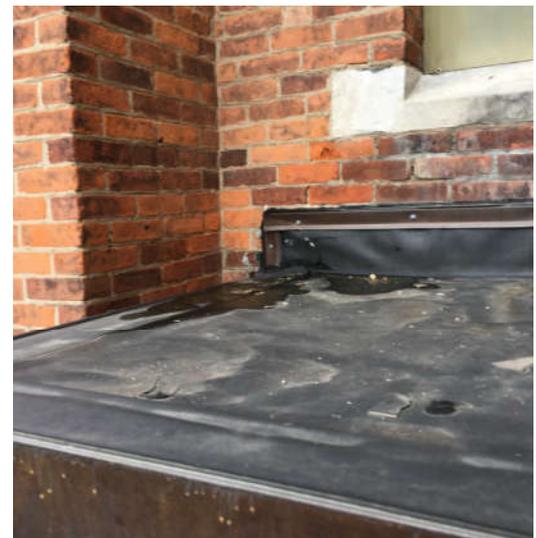
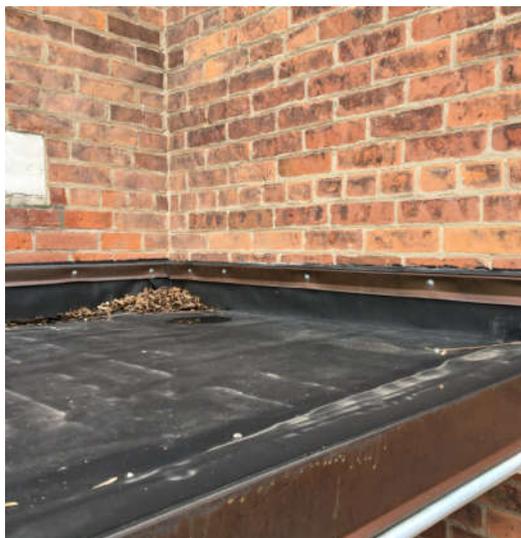
Fig 50 - East exit Church basement roofing

Fig 51 - East exit Church basement roofing

*Inspect sill flashing at East exit roof; replace sealant at fastener locations as required.....\$ 600 [P]*  
*Inspect roofing areas, clear of debris, inspect for punctures ..... Annual maintenance [E]*

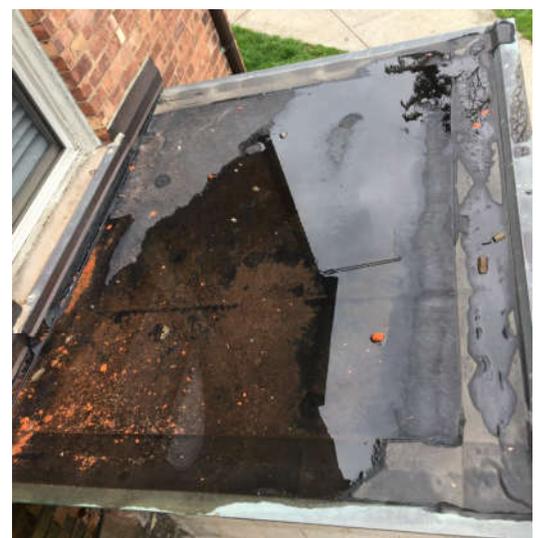
Fig 52 - East exit Parish House basement roofing

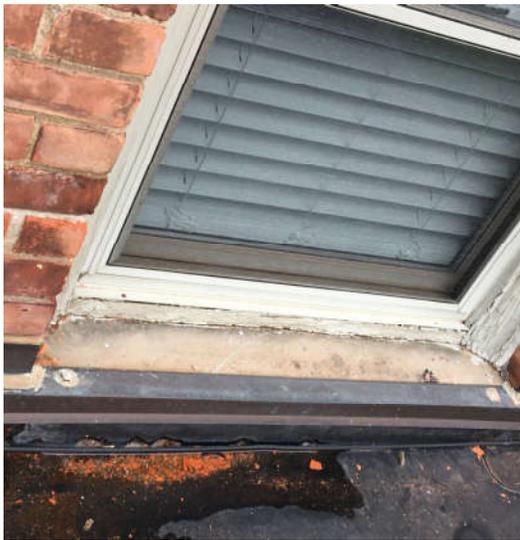
Fig 53 - East exit Parish House basement sill flashing

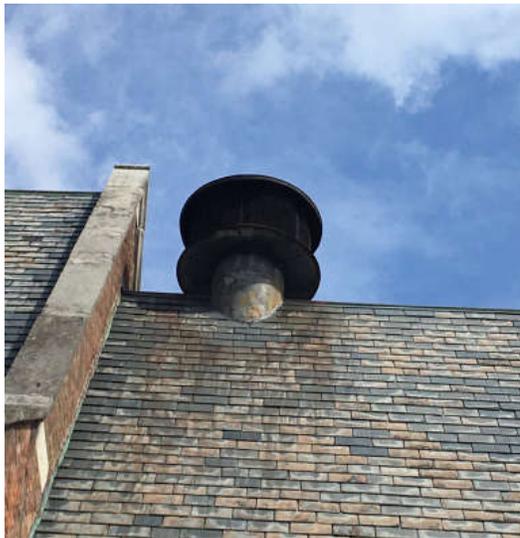
The Church roof does not appear to have ventilation except the portion over the Chancel. There is an existing older-style gravity vent mounted at the ridge of the Chancel roof area and an interior grille at the top of the Church wall adjacent to the Chancel lowered ceiling area. When replacing the roofing, we recommend incorporating ventilation to the ceiling/attic area - ideally air would enter at the eaves, flow up underneath the roof deck, and out at a continuous ridge vent. The Parish House roof appears to be ventilated only by the monitor at the ridge above the south entry. The Chapel roof does not appear to be ventilated.

Fig 54 - Church gravity ventilator

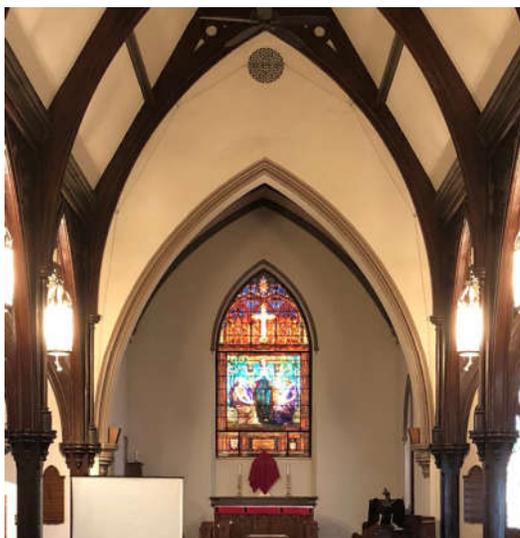
Fig 55 - Church ventilation - grille

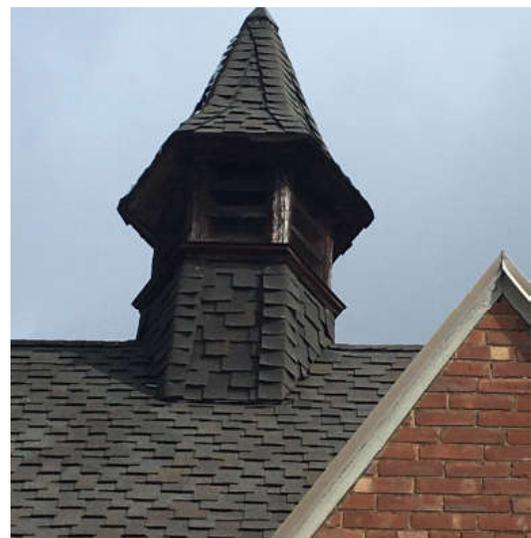
Fig 56 - Parish House ventilator

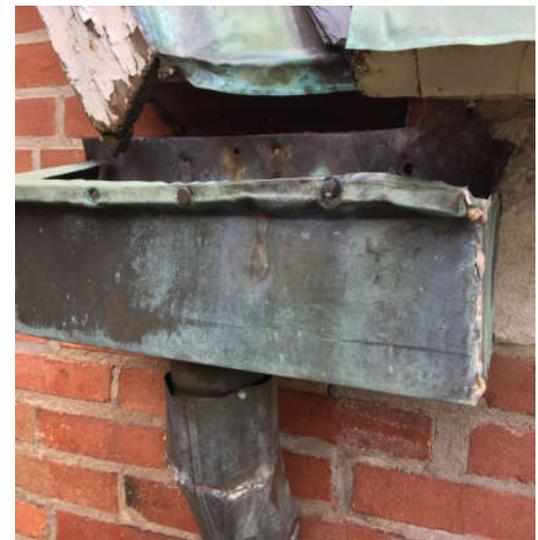
Fig 58 - Lower Entrance gutter

evaluated to ensure proper attachment.. The North Entrance has two trough gutters, the one at the northeast valley at the Lower Entrance is in poor condition – bent, caulked, and has many exposed fasteners – and should be replaced.

- Provide expansion joint at center of north and south elevation gutter lengths .....\$ 16,300 [P]*
- Replace gutter at northeast valley of Lower Entrance .....\$ 2,700 [P]*
- Reconfigure and replace the gutter to downspout connection at the west side of South Transept .....\$ 13,800 [E]*

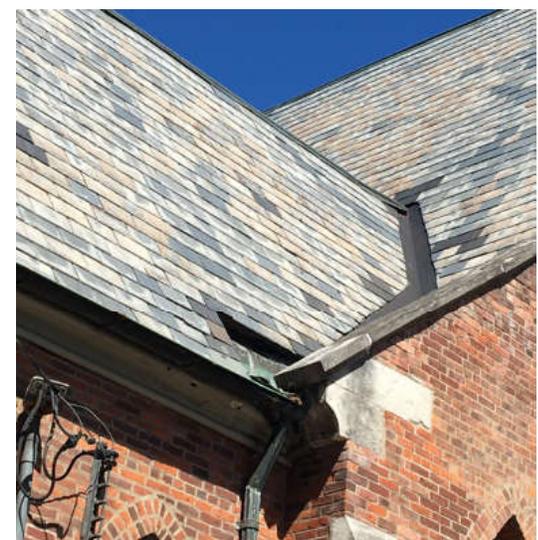
Fig 59 - East elevation gutter at South Transept

As noted previously roof valleys collect and move a great deal of water during rain events. Each side of the South Transept has stormwater issues – the east side has a large built-in gutter area at the base of the valley that connects to a short gutter. Below at the gutter along the wood eave molding there is a sheet metal patch repair that indicates previous water damage was an issue, refer to Section 7, **CARPENTRY**. Currently there does not appear to be a water infiltration or leaking issue at this location so we recommend maintaining the valley and gutter flashings to be sure water flows and exits the building surfaces.

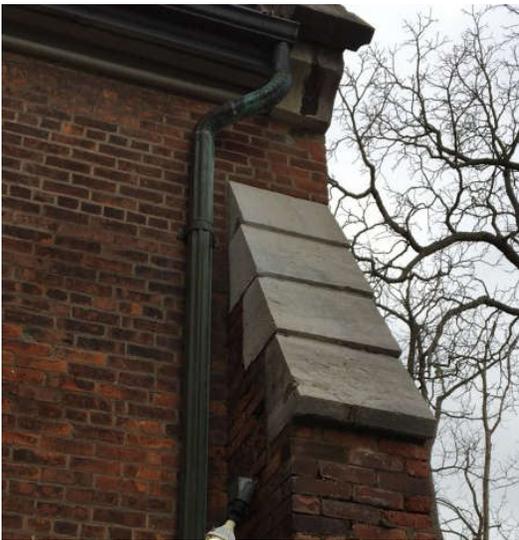
Fig 60 - West elevation downspout at South Transept

At the west side of the South Transept, water repeatedly spills over the gutter at the downspout connection location. We were there after a rain storm and observed water continuously dripping from the downspout location, along the masonry buttress, and down to the asphalt driveway. We are not sure if the issue is based on a clogged downspout connection, debris built-up in the gutter, or a poorly detailed downspout to gutter connection. We recommend that gutters and downspouts be cleaned and the connection evaluated to understand if it continues to be an issue. If the downspout continues to be an issue, replacement and reconfiguration is a priority; we provided a price for this repair. Refer to Section 5, **MASONRY** for stormwater issues impacting masonry systems at this location.

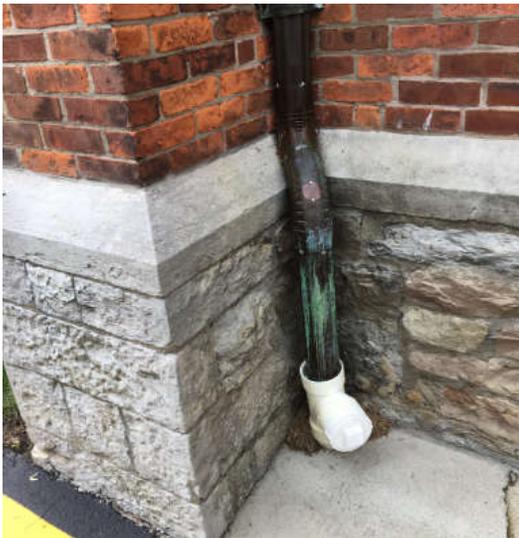
Fig 61 - Typical hub connection

The Church has corrugated round copper downspouts that drain into hubs. The hubs do not have cleanouts and some portions are constructed of plastic piping. We recommend you plan to replace all hubs to be of cast iron material with a cleanout installed for durability and to ensure the ability to maintain the underground system. One east elevation downspout (Fig 62) hovers over a vertical downspout that empties into an open hub. We recommend you tie these two downspouts together. Three north elevation downspouts (Fig 63) appear to be directly buried underground and we recommend you dig up these locations to understand if they are tied into an existing system or empty into the ground and correct the connection appropriately with cast iron hubs and at least one cleanout. One downspout is located along the West elevation below the Belfry.

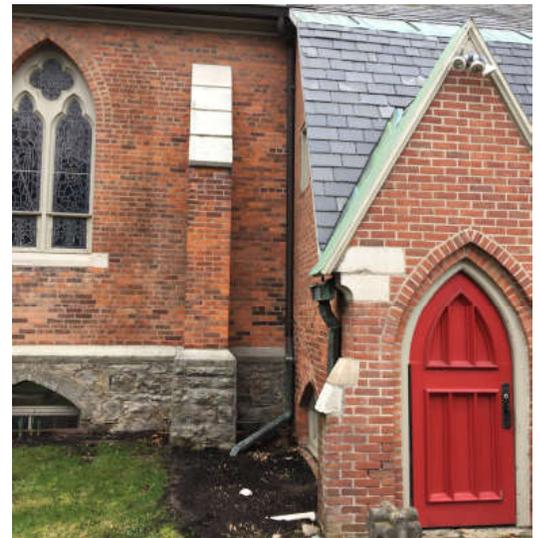
Fig 63 - Lower North Entrance (2) downspouts to grade

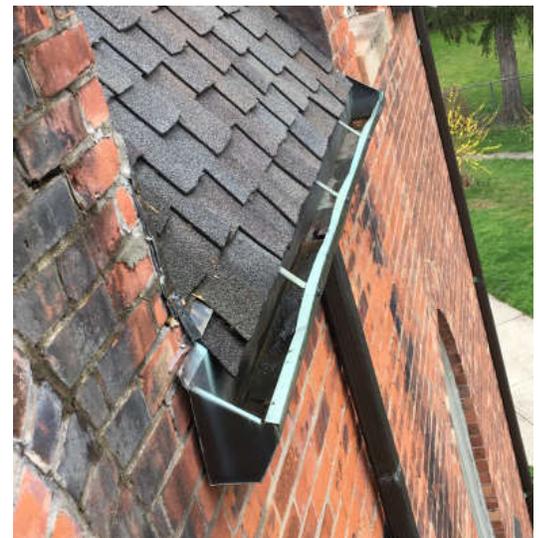
Parish House and the Chapel roofs have custom-fabricated copper gutters assumed date to the installation of the asphalt shingle roofing. Due to the lack of overhang and parapets and dormers punctuating the eave line, stormwater management is complicated. Many gutters are bent and require straightening. Fabrication of the gutters and downspouts is poorly detailed. Gutters should be soldered watertight, but the gutters appear to be folded and riveted. The downspouts should be loosely connected to the gutters to allow for movement; your downspouts are soldered tight to the gutters causing the potential for tearing/breaking when moving due to expansion and contraction. We recommend repairing these connections when performing work at the dormer and parapet flashings, copings, and roofing.

Fig 64 - Parish House gutter, typical

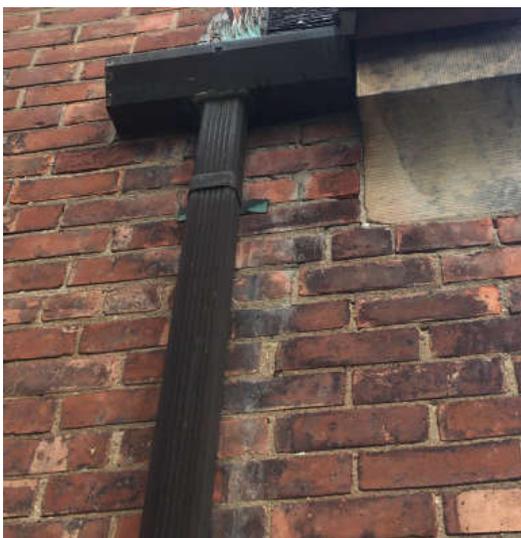
All downspouts except for one at the east elevation drain into hubs without cleanouts. We recommend you plan to install cleanouts at the hubs and straighten downspouts damaged by lawn equipment.

Fig 65 - Parish House downspout, typical

*Straighten bent gutters; Repair gutter to downspout connections* .....  
 .....\$ 18,400 [P]  
*Provide cast iron cleanouts at hub locations* .....\$ 13,200 [P]  
*Straighten downspouts damaged by lawn equipment* .....\$ 700 [P]

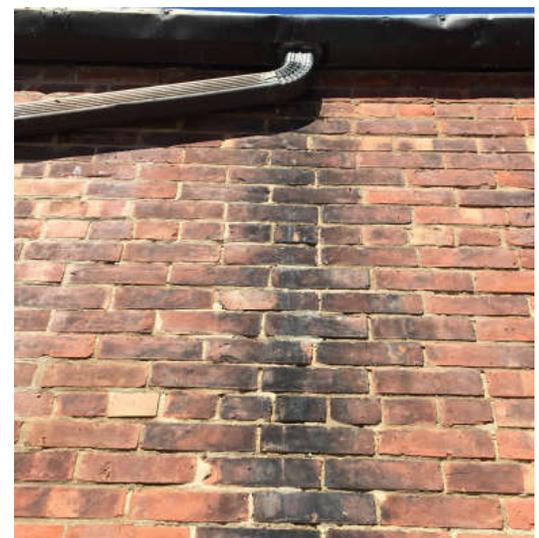
At the Education Wing east elevation, streaks on brick masonry directly below the downspout connection to the gutter makes us suspicious that water overflows at this location. Providing a metal strainer at the downspout drop and repairing the drop to eliminate the soldered connection to the gutter should improve the situation.

Fig 66 - Education Wing gutter and downspout

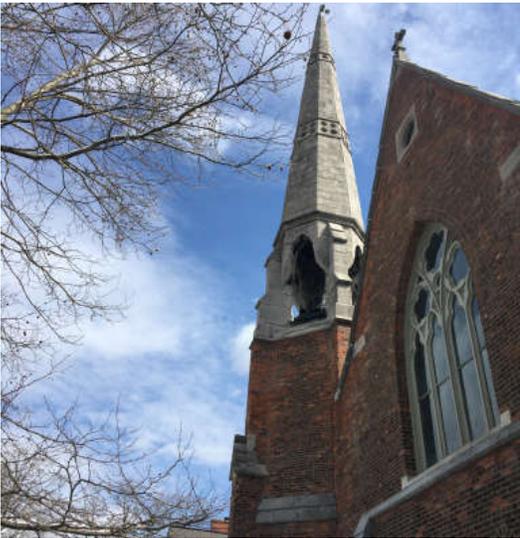
Fig 68 - Church spire and belfry

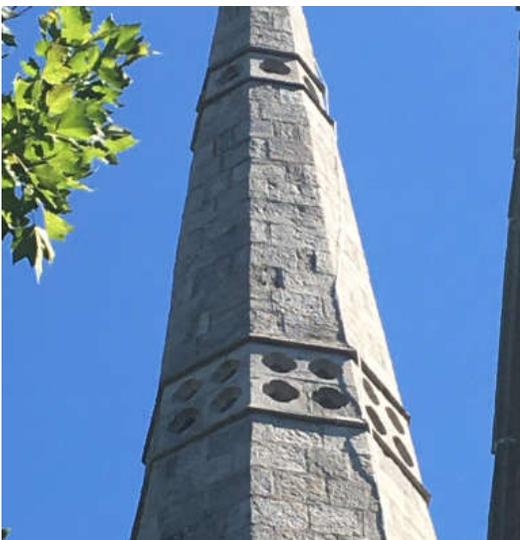
Fig 69 - Spire

The Church is constructed of a combination of stone masonry - foundations and watertable, Belfry and spire, gable copings, gable and parapet kneestones - and brick masonry walls in fair-to-good condition.. The gray stone spire is set with smoothly dressed blocks of stone coursed up to a carved stone steeple cross. The stone foundation at the west elevation and the watertable consist of rubbed (smooth)-finish cut coursed stone; the remaining foundation wall (north, east, and south) elevations are rock-finish random range coursed ashlar masonry. Most stone joints are in relatively good condition but maintenance repointing and repairs should be planned.

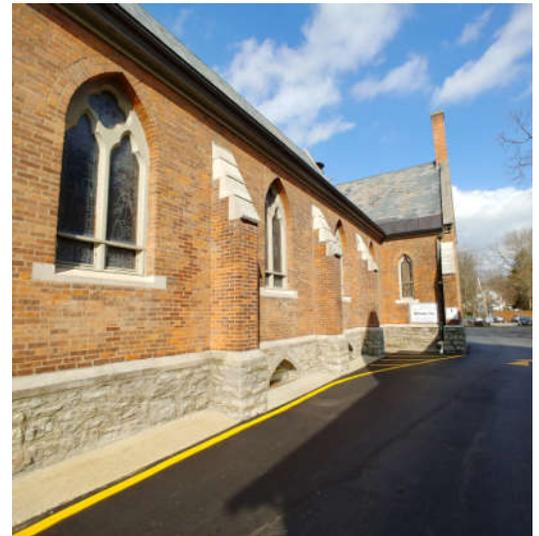
Fig 70 - Church, typical masonry

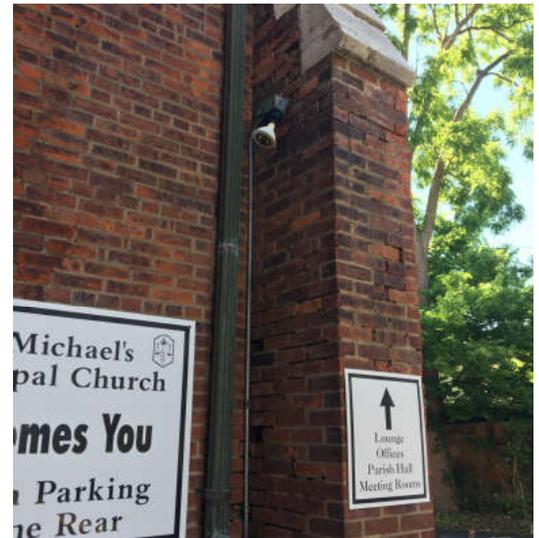
Fig 71 - South Transept buttress

The brick masonry walls are mostly in good condition except at the west side of the South Transept where water repeatedly spills over the gutter at the downspout connection location. Evidence of the repeated water problem was noted by the open joints in the brick masonry buttress and efflorescence at the brick surfaces and spalling brick on the south elevation of the South Transept wall. Exterior masonry surfaces dry by evaporation. When water evaporates from the face of masonry it carries soluble salts which are deposited as

*Repoint West butress and South elevation of South Transept, replace spalled bricks, and clean efflorescence .....\$ 27,700 [E]*  
*Repoint at East elevation gable copings at slope changes .....\$ 14,400 [P]*  
*Remove North Entrance site wall, repair stone steps, and repoint brick masonry landing wall.....\$ 16,700 [P]*

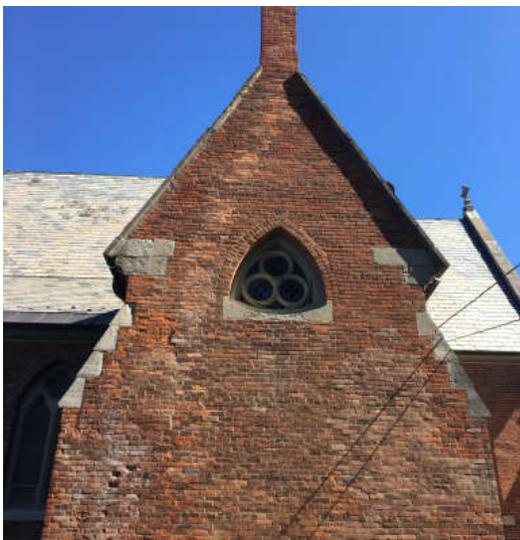
Fig 72 - South Transept

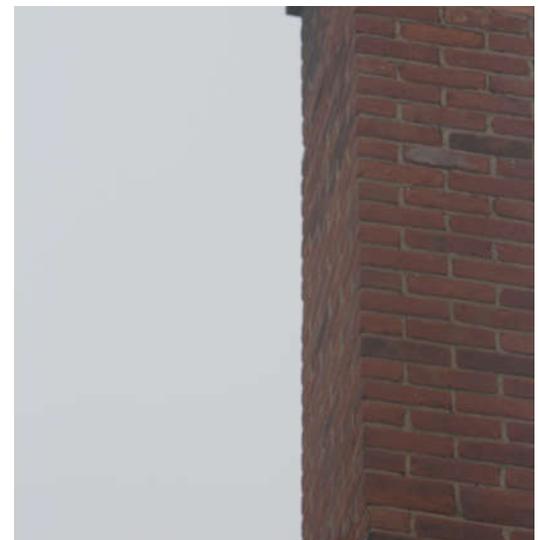
Fig 73 - South Transept chimney

There are open joints at the upper portion of the South Transept chimney that need to be addressed; masonry cap to the chimney should be inspected and repaired when access is provided to perform repointing work. There is efflorescence and open joints along the stone copings and brick masonry at the top of wall where the gable end slope changes along the East elevation. Repair should include coping flashing replacement, removal of efflorescence residue, and repointing of open joints. Typically, deterioration is related to former or current roof or gutter leaks; we recommend the roofing or flashing repairs be completed first and then the masonry repointing be addressed.

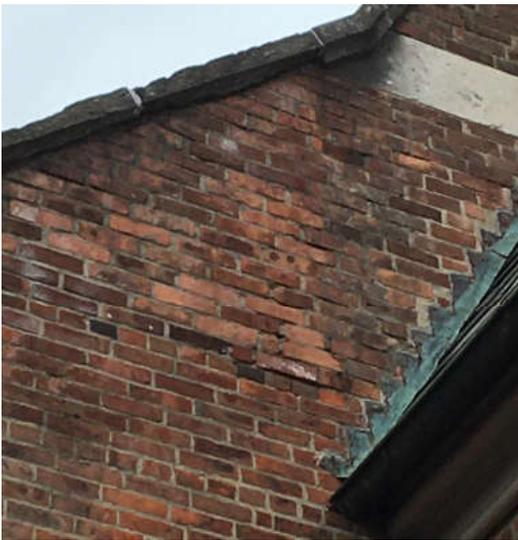
Fig 74 - Church wall at slope change

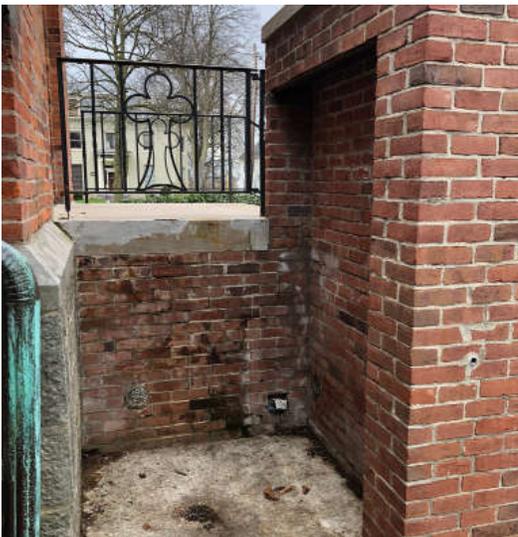
Fig 75 - North Entrance site wall

The North Entrance exterior site wall adjacent to the limestone steps is in poor condition. Moisture is moving through the masonry based on efflorescence and failing mortar joints. Located directly next to the North Entrance to the Church, this is unsightly and will continue to deteriorate until addressed with proper repairs. As this brick masonry wall does not have a purpose (constructed to conceal a wheelchair lift that was removed), we recommend you consider a holistic solution to this area – a solution that addresses site stormwater issues and improves site grading and drainage. We have provided a price to remove the brick site wall and provide repairs to the stone steps and brick landing wall.

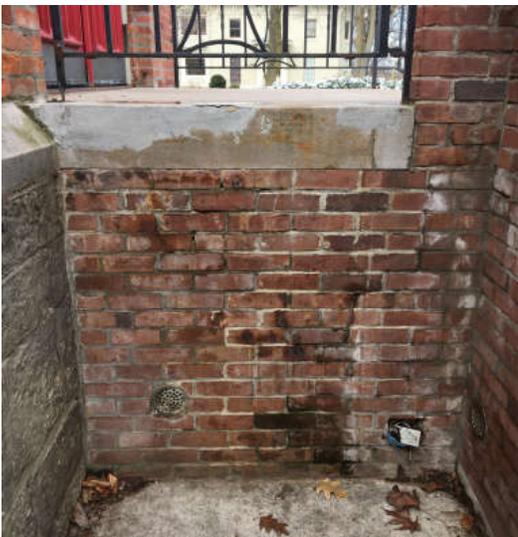
Fig 76 - Masonry deterioration

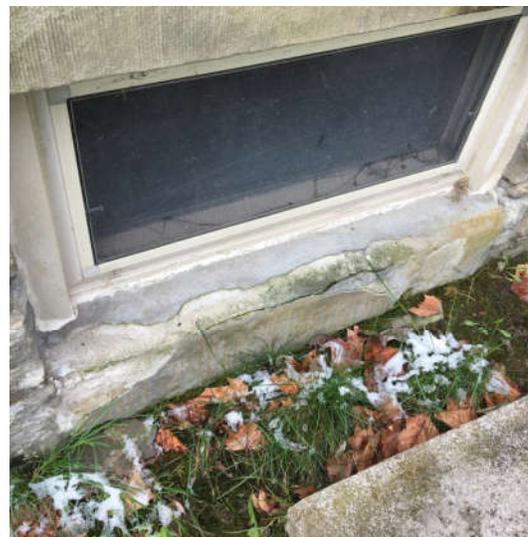
Fig 77 - Parish House basement windows

Basement windows have parged stone sills that are failing. Moisture enters cracks in the parging, is subject to freeze/thaw cycles, and continues to crack and spall. We recommend replacing parging where compromised and prior to replacing, verifying underlying stone joints are repointed as needed.

Replace stone parging at basement openings.....\$ 6,000 [P]  
 Rebuild brick masonry dormer and parapet walls (following roofing and flashing work) (1) East + (1) South + (1) North and (1) East gable .....  
 .....\$ 44,000 [E]  
 Repoint brick masonry at dormer and parapet walls and arched window surrounds.....\$ 42,8500 [P]

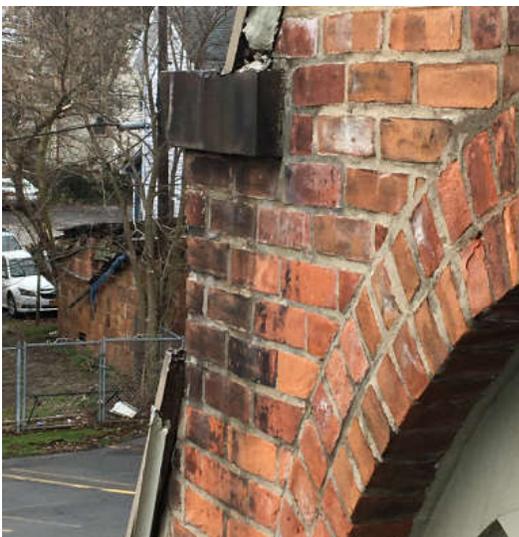
Fig 80 - Gable parapet deterioration

Brick masonry - gable dormers, parapets, and arched window surround locations - is in poor condition – brick is spalling and there are lots of open joints. The masonry joints at the dormer shoulders have deteriorated so much we assume the flashing at the back of the dormer has failed. Due to extreme water infiltration, brick masonry has moved out of plane in two locations at the East elevation. For the purposes of this report, we recommend flashings be replaced and brick masonry rebuilt at dormer locations. We believe it is only time before other dormers get to this point of joint deterioration and therefore a roofing and flashing replacement project at all dormers should be planned.

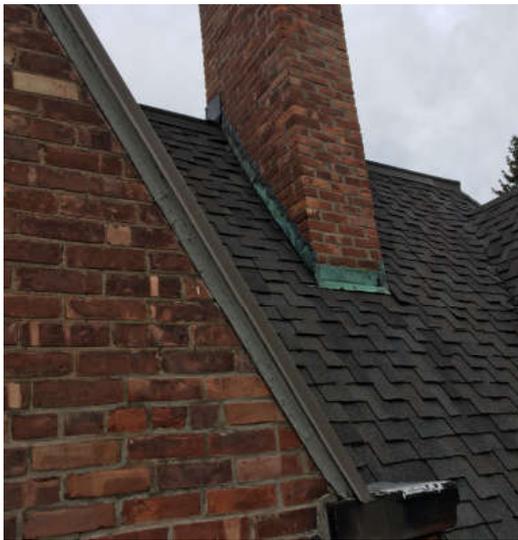
Fig 82 - Chimney flashings

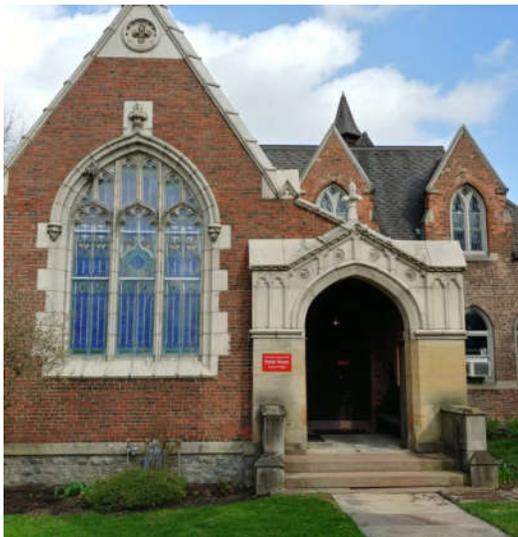
Fig 83 - Chapel, West Entrance

The terra cotta at the West Entrance copings have open joints. There is a vertical crack from the upper coping, through brick masonry, and into the Entrance arch members. One arch stone appears to have an open joint and have slightly slipped. We recommend repointing all open joints and observe the arch members for future movement.

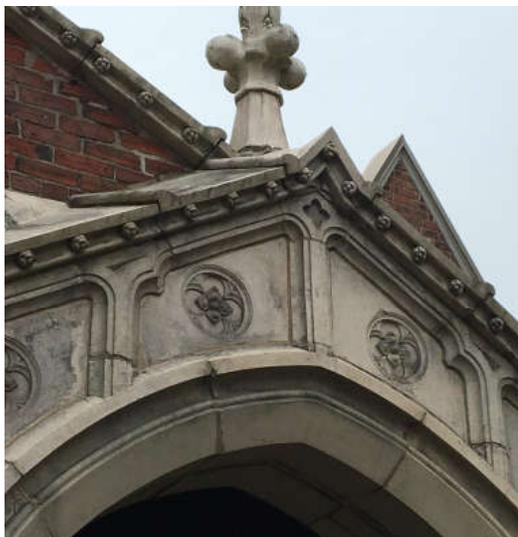
Fig 84 - Terracotta arch detail

“Brownstone” architectural terra cotta, popular from 1880-1930, is manufactured from ceramic materials to produce a fired product that has been historically used for decorative trim elements or panels to mimic stone masonry. Deficiencies are most often traced to original manufacturing and detailing, or open joints that cause spalling, cracking, and rust-jacking of concealed steel anchors. *Attachment 11* is a resource for typical characteristics and addressing failures with terra cotta units.

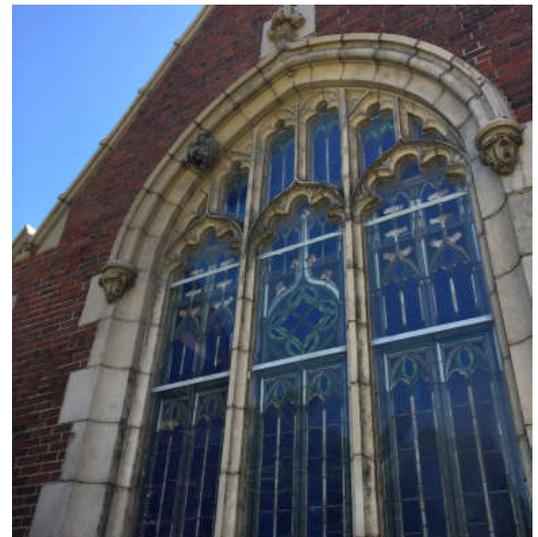
The West window terra cotta sill members are in poor condition and have been repaired over the years with sealant-filled cracks. Although the repairs to the terra cotta are unsightly, when properly maintained,

Fig 87 - West window terracotta trim

these members can remain in-place and be serviceable. It appears water enters at the cracks along the horizontal joint at the sill and the entrapped moisture causes additional cracking of the terracotta. We recommend you replace the joint sealant with an appropriate mortar and carefully attend to and maintain any horizontal-facing joints to keep watertight.

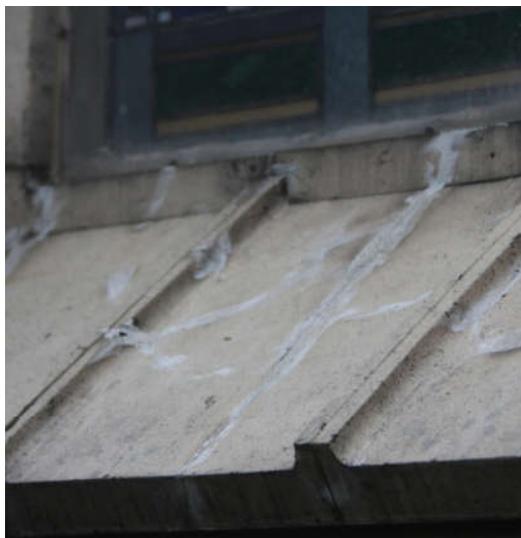
Fig 89 - Sill members detail

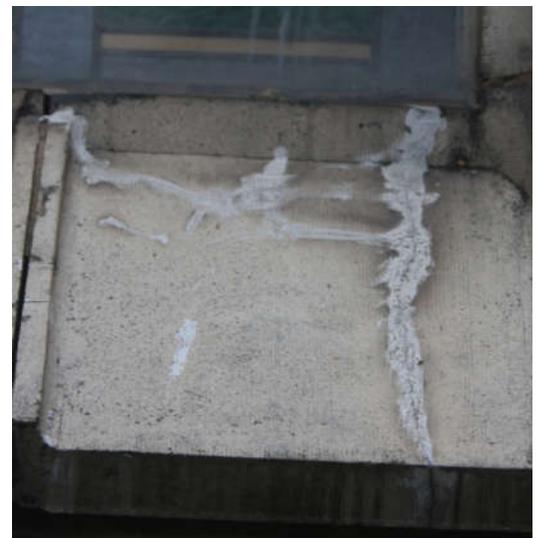
Fig 90 - Sill members detail

*Repoint terra cotta copings and Repoint brick masonry at crack and repoint arch terra cotta member; evaluate over time.....\$ 33,100 [P]  
Replace sealant with appropriate mortar at terra cotta sill members and repoint.....\$ 2,500 [P]  
Repoint joints at exterior steps.....\$ 1,200 [P]*

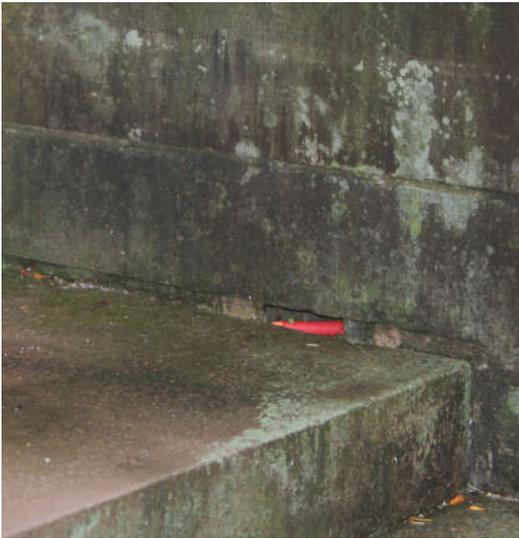
Fig 91 - West Entrance steps

Joints between the Medina sandstone steps and stone cheek (side) walls are open and the stones have shifted. Maintenance of exterior masonry steps is often an ongoing issue and we recommend joints are raked and repointed with an appropriate mortar. We recommend using mortar over caulk because caulk does not provide structural support and obscures the condition of joints.

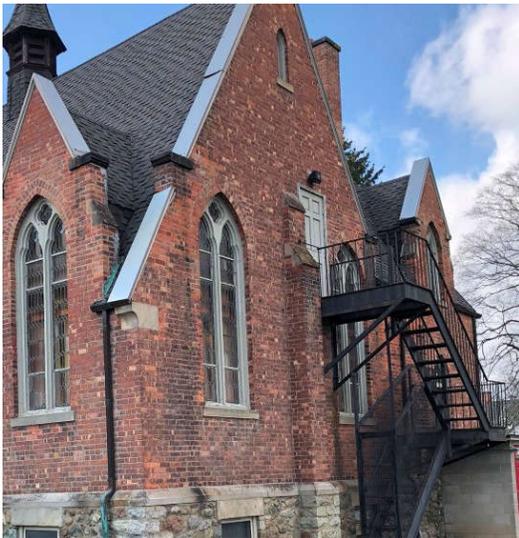
Fig 92 - Parish House fire escape

The exterior metal stairs from the 2nd floor Parish House offices are a continual maintenance issue – requiring frequent inspection and finishing. Exterior fire escape stairs are subject to special code restrictions based on structural loading capacity and may require annual inspection by a licensed structural engineer. As code requirements vary based on jurisdiction, we recommend you confer directly with your local code enforcement official to determine viability of use of these stairs in the future.

*Evaluate use of and condition of exterior fire escape stairs with code official .....Staff [E]  
Hire a qualified structural engineer to inspect stairs for capacity and develop a list of repairs.....\$ 1,600 [E]*
