Condition Report

## ST. MICHAEL'S EPISCOPAL CHURCH

23 Main Street  
Geneseo, New York

OCTOBER 2020

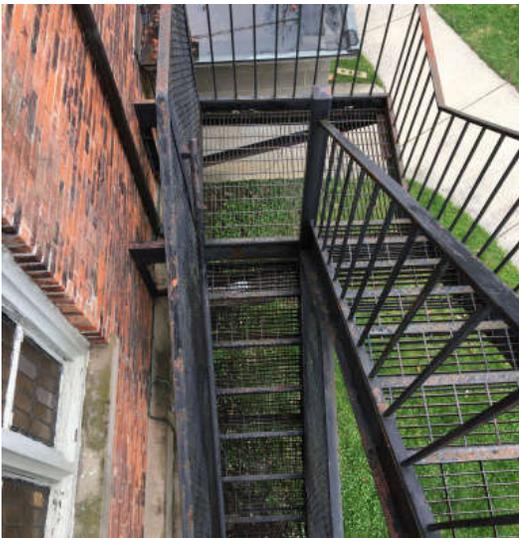
The exterior metal stairs from the 2nd floor Parish House offices are a continual maintenance issue – requiring frequent inspection and finishing. Exterior fire escape stairs are subject to special code restrictions based on structural loading capacity and may require annual inspection by a licensed structural engineer. As code requirements vary based on jurisdiction, we recommend you confer directly with your local code enforcement official to determine viability of use of these stairs in the future.

Fig 93 - Fire escape looking down

*Evaluate use of and condition of exterior fire escape stairs with code official .....Staff [E]  
Hire a qualified structural engineer to inspect stairs for capacity and develop a list of repairs.....\$ 1,600 [E]*

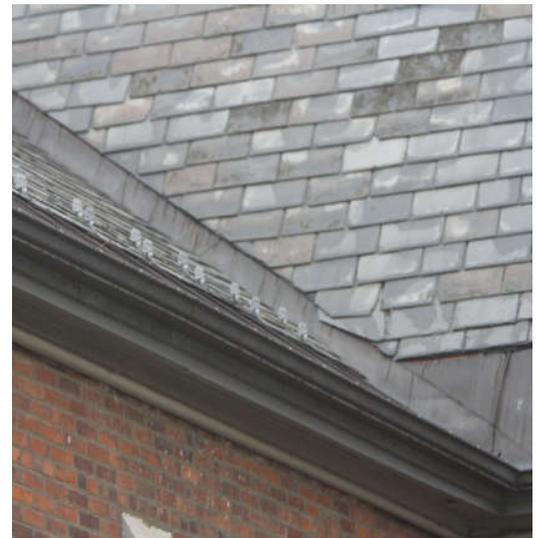
In general, the standing trim along the roof eaves is in poor-to-fair condition due to exposure from lack of an overhang, weathering, and lack of maintenance (periodic painting). The eave molding at the South Transept is covered in sheet metal and it appears the original profiled wood was removed. We recommend eventual replacement (when access is provided for a roofing or flashing replacement project) with wood molding profiled to match existing. Rake moldings at North Entrance and Parish House are weathered and in need of painting.

Fig 94 - South elevation eave molding

*Replace deteriorated eave molding at East elevation South Transept .....*  
*.....\$1,200 [P]*  
*Provide limited carpentry repairs to rake and eave moldings .....*  
*.....\$3,000 [P]*

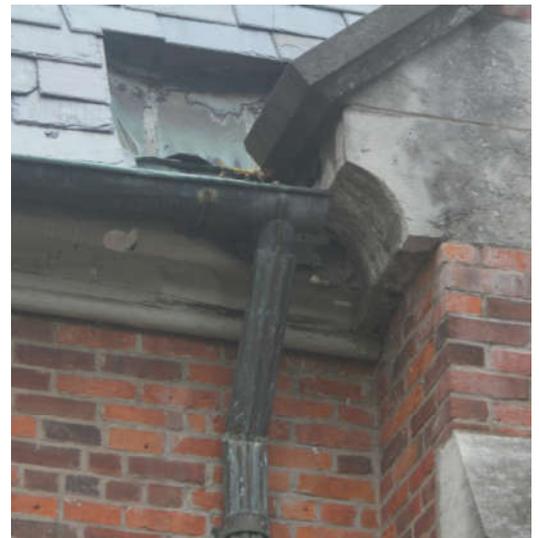
Fig 95 - South Transept eave molding

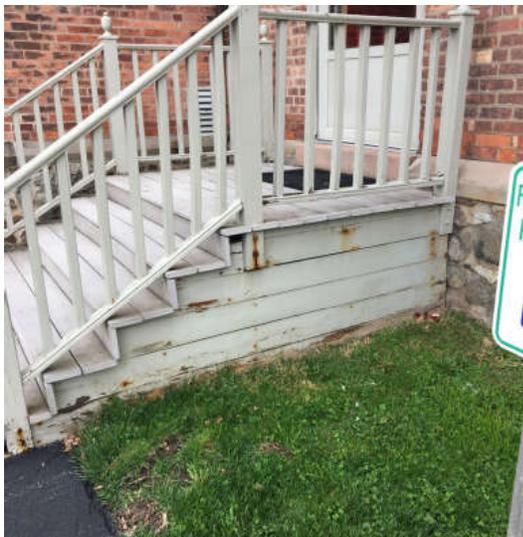
The exterior wood stair at the South Entrance to the Parish House is constructed of pressure-treated and plastic lumber components of a recent vintage and is in poor condition. The composite lumber treads are warping, the guard is failing at the lower rails, and the posts appear to have moisture damage. The fasteners are ferrous and rusting – mostly an aesthetic issue that could be fixed by replacing with hot-dip galvanized fasteners and wood elements painted.

Fig 96 - Parish House exterior stairs

These stairs are of residential quality; based on the location and function for the Parish, we recommend replacing these stairs with higher quality materials, proper handrails with extensions, and more durable framing connections, detailing, and proper foundations.

*Replace exterior stairs, guard, and provide handrails.....\$22,000 [P]*

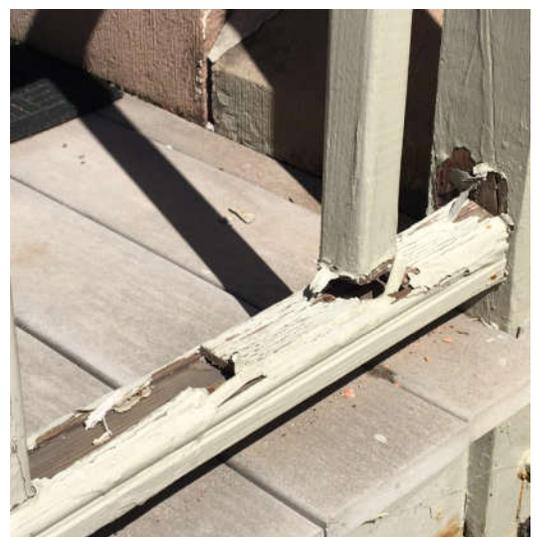
Fig 97 - Bottom rail detail

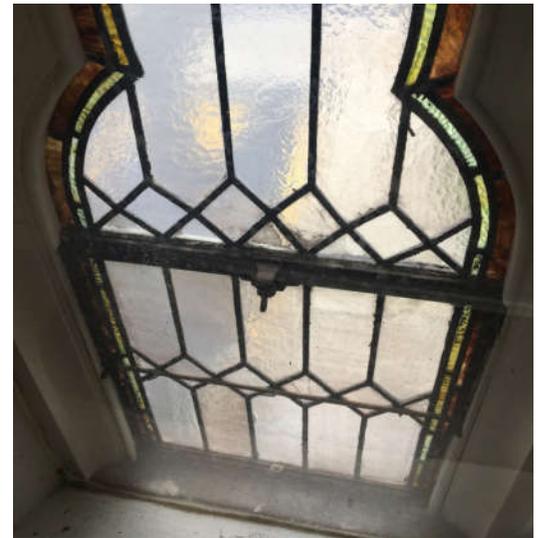
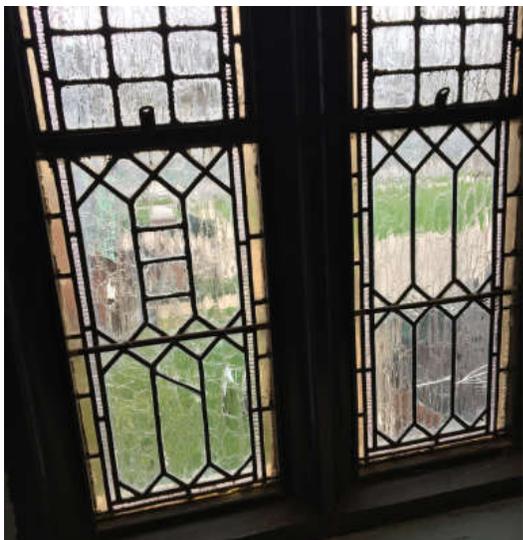
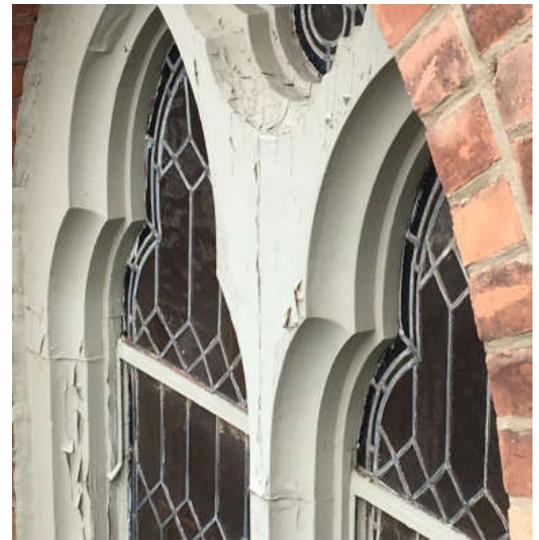
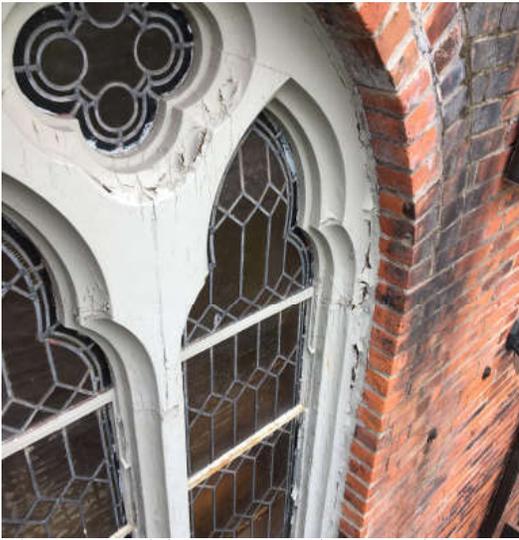
Fig 103 - Parish House window interior

Fig 104 - Parish House window interior

Fig 105 - Parish House window exterior

Fig 106 - Parish House window exterior

There are two-story lancet-arched leaded glass windows at the Parish House's east and south elevations and smaller lancet arched leaded glass windows along the 2nd floor east, north, and west elevations. Although a detailed condition report on the leaded glass is not part of the scope of work of this report (and outside of our area of expertise), we did note locations of bulging of the leaded comes, broken and dirty glazing, and poor condition of the steel ventilator sash. We did not try to open the windows due to their somewhat fragile appearance.

Windows which hold leaded glass are constructed of wood and the finish is in poor condition. Paint is peeling exposing bare wood to the weather. We recommend you perform minor carpentry repairs, prepare and paint. With the lack of overhang and depth of the wood framing profiles, we recommend you take care of this issue but wait on perform extensive repairs to the leaded glass until water issues are repaired for the roofing, flashing, and masonry.

*Provide limited carpentry repairs when preparing to paint windows*  
*(allowance) .....*  
*.....\$4,700 [P]*

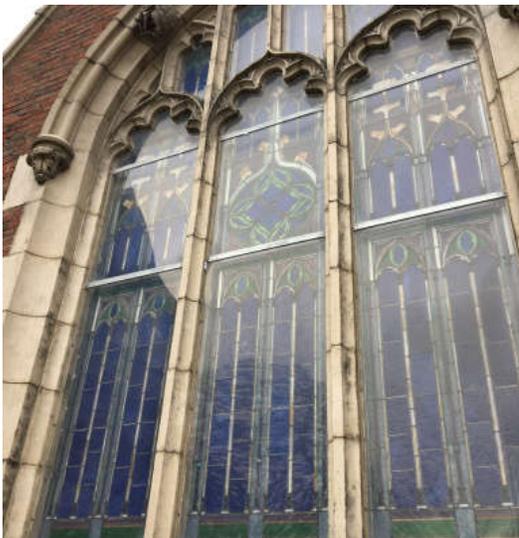
Fig 107 - Chapel - West window.

The West elevation leaded glass window is covered with clear acrylic protective panel. We did not observe any mechanism for ventilation and recommend these panels be removed, the window inspected, and panels reinstalled with allowance for proper ventilation. The north elevation windows are lancet-arched leaded glass windows without protective panels. The lower sash is a pivot hinged operable sash set within a metal frame. It appears the metal and wood framing elements have recently been finished and do not require attention at this time.

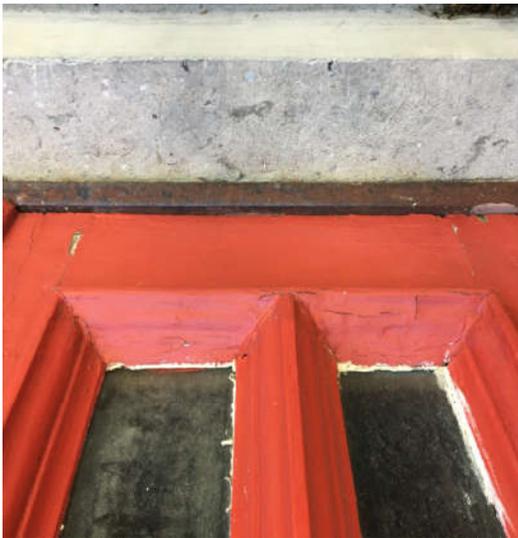
The three exterior doors of the Church (West elevation, and North, and Lower North Entrance) are rail and stile wood doors with lancet-arched upper panels and textured glass set in deep panel moldings. We observed one cracked glazing panel and one unfinished lower wood panel at the North Entrance double doors indicating a potential recent repair, and peeling, flaky paint. These doors also have a rusting threshold that should be replaced with a higher-quality bronze threshold.

Fig 114 - West door detail

At all door locations, the lower rail is the most vulnerable to deterioration based on their proximity to ice and snow build up and exposure to de-icing salts; we recommend you maintain the paint finish on this portion at all locations. The exterior doors will require restoration of deteriorated wood panels/stiles/rails, replacement of deteriorated glazing putty, installation of weatherstripping, and replacement of broken glass panes. The report provides a budget allowance amount for typical restoration work to the exterior doors in order to extend the service life of these doors.

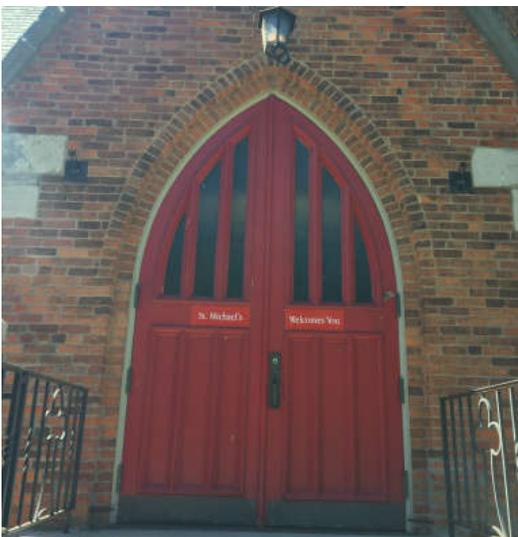
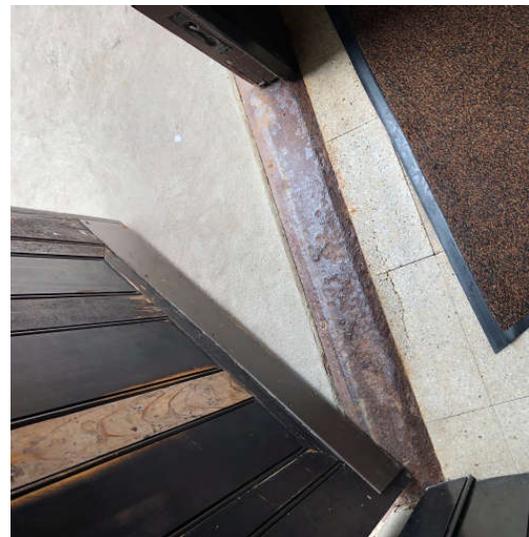
Fig 115 - North Entrance doors

Fig 116 - North Entrance door detail

| <i>Repair existing North Entrance double door.....</i> | <i>\$ 3,900 [P]</i> |

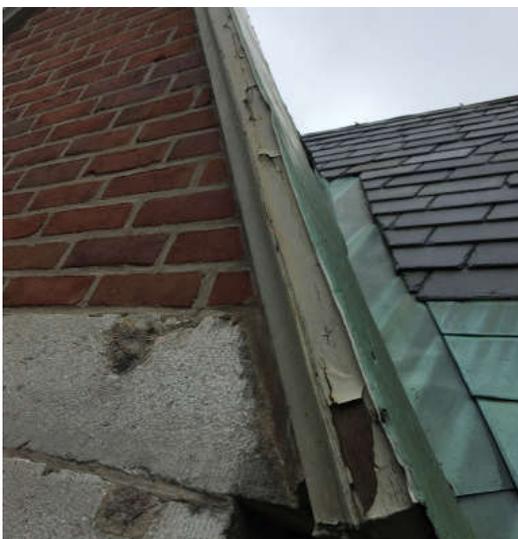
Exposed exterior wood elements require preparation and painting: eave and rake moldings, window sash and framing, and the exterior stair as these elements show evidence of deteriorated paint from weathering and lack of maintenance. In many locations, the paint is cracked and checked, alligatored, or peeling, and exposing bare wood. Areas of bare wood should be addressed as soon as possible to prevent rot and loss of original material. We recommend all exterior wood trim that has cracked peeling paint be prepared by removing paint to bare wood, primed and re-painted.

Fig 123 - Existing rake molding

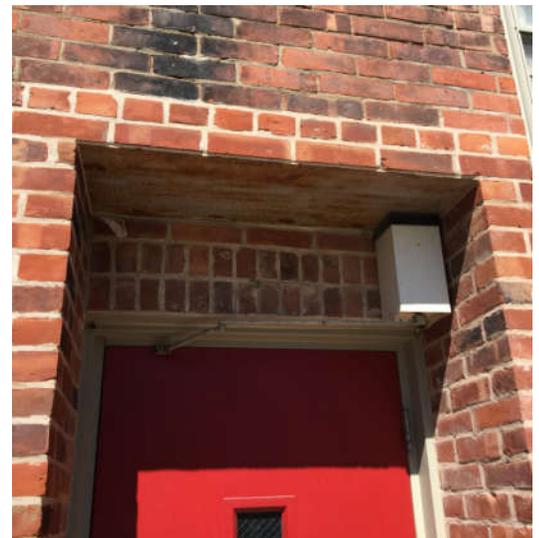
All metal elements require preparation and painting: fire escape stair components, guard at North Entrance, and the exposed steel lintel at the lift entrance door.

Fig 125 - Existing metal lintel

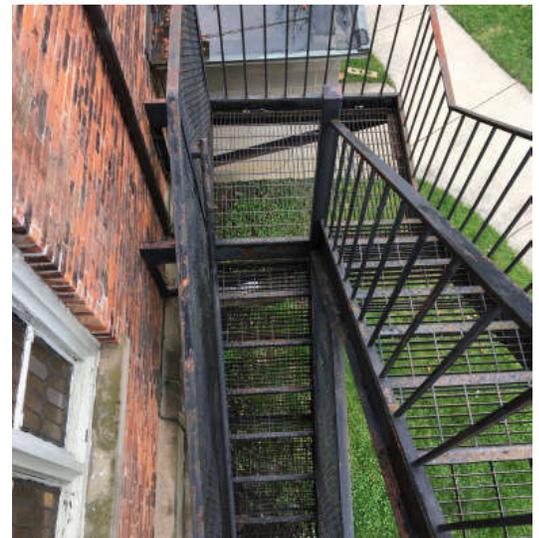
Fig 126 - Existing metal stair.

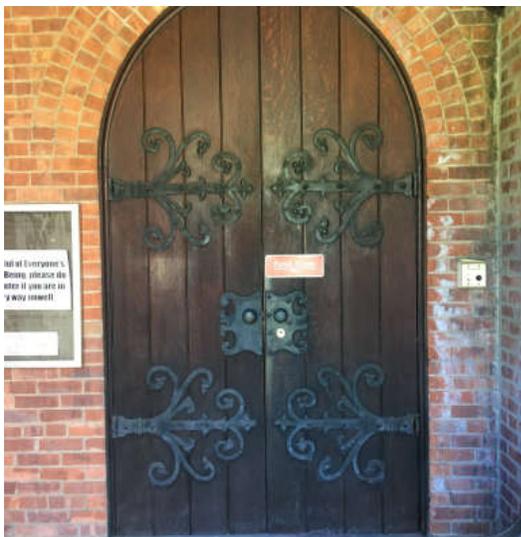
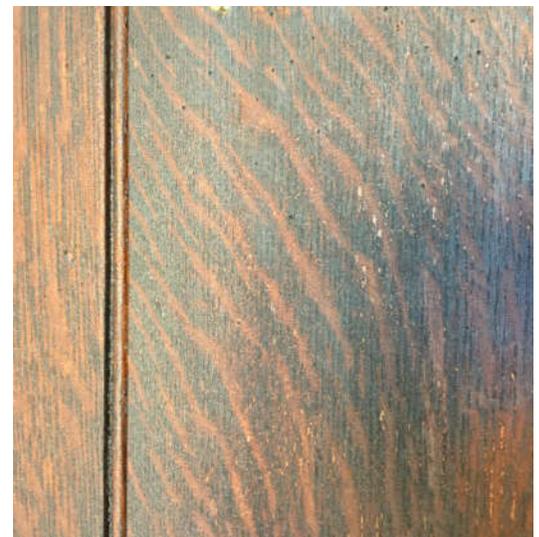
The Chapel exterior doors at the West Entrance are finished in a transparent (stained) finish. Transparent finishes are not as durable as paint finishes and require frequent refreshing. The doors require refinishing; the existing wood surface appears to lack any finish application and when the wood substrate starts to darken to black, that is an indication the wood substrate will not hold a finish. We recommend when refinished, the process includes removing any remaining finish, sanding to bright wood, and priming and finishing with a high-quality exterior finish. This will provide a durable, long lasting finish and protect the original doors and frames.

Fig 127 - West Entrance door

Fig 128 - West Entrance door detail

*Prepare and stain exterior wood at Chapel doors.....\$3,200 [P]*

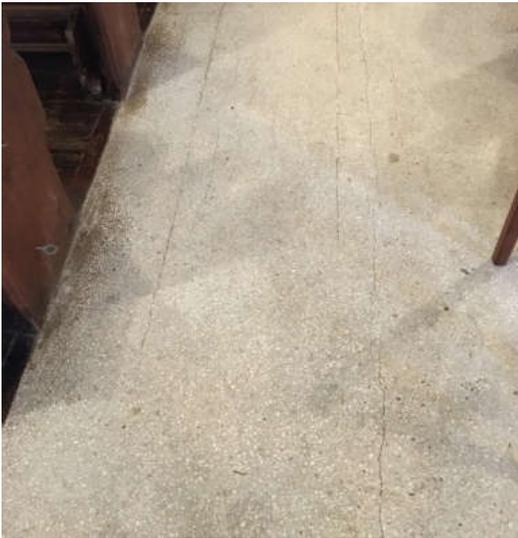
The Church's terrazzo flooring is cracking in locations. The terrazzo, a poured cementitious mix, is set on the 1st floor framing over the Basement Lower Hall. Cracking may be original to construction if an allowance for movement was not detailed appropriately in the installation. We noted several locations of cracking near entrance doors and have concern that cracking may be impacted by foot traffic

Fig 137 - Terrazzo flooring cracks

carrying snow and de-icing salts. We recommend you place walk-off mats to decrease water collecting at this areas and you monitor cracks to ensure they do not enlarge and become a tripping hazard.

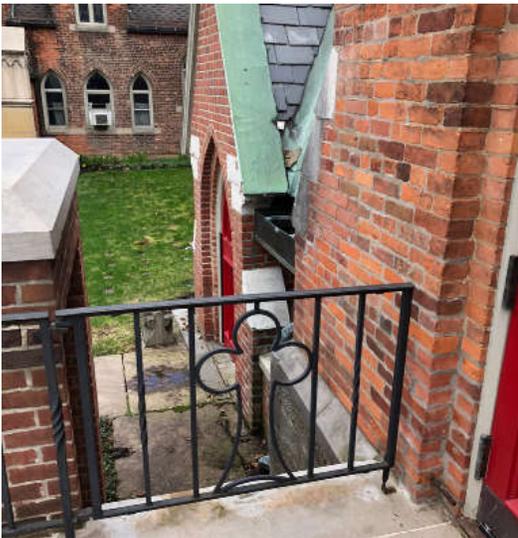
The metal guard at the North Entrance landing does not meet guard requirements for height. The landing is located over 30-inches above grade and therefore a 42" high guard is required – 36" high for existing construction is allowed. We recommend you modify this guard to meet height requirements.

Fig 138 - North Entrance guard

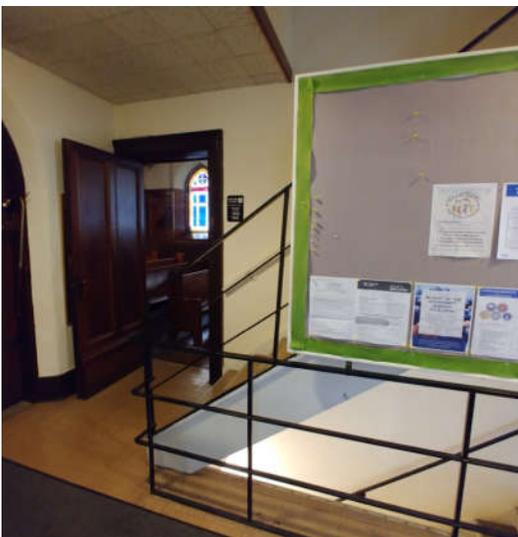
The Parish House interior stairs does not meet guard requirements for height nor for baluster spacing. Aside from the height deficiency, guards shall have balusters spaced per code. We recommend you infill this rail with balusters or netting to meet code.

Fig 139 - Parish House interior stair guard

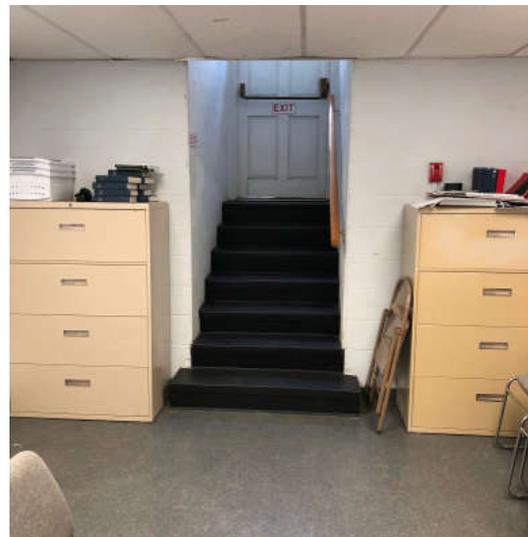
Interior spaces within the Church, Education Wing, and Parish House are set at a variety of floor elevations or levels; and there are many set of interior stairs to connect each floor level. Handrails at the basement interior steps in the Parish House hallway, and handrails at the (3) exit locations from the basement are not to current code requirements for continuity, location at each side of stair, or handrail extension. While these handrails may have been legal per the code in effect at the time of installation, we recommend that handrails along

Fig 140 - Parish House basement exit stairs

egress routes from occupied assembly spaces (Lower Hall and the Sanctuary) be replaced to meet current code requirements.

*Replace handrails at interior stairs (allowance).....\$1,800 [E]*

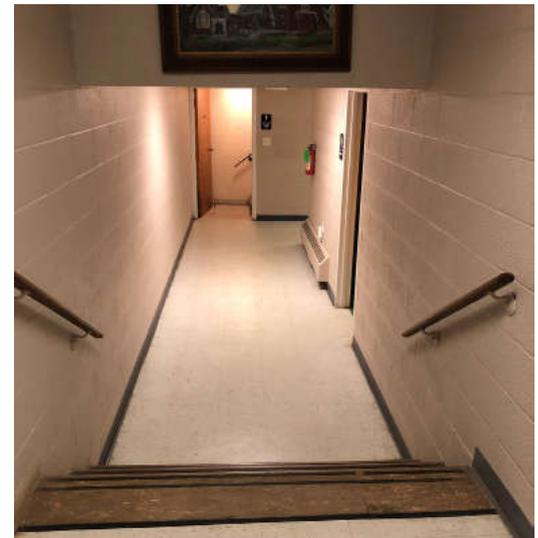
Fig 141 - Basement interior stairs

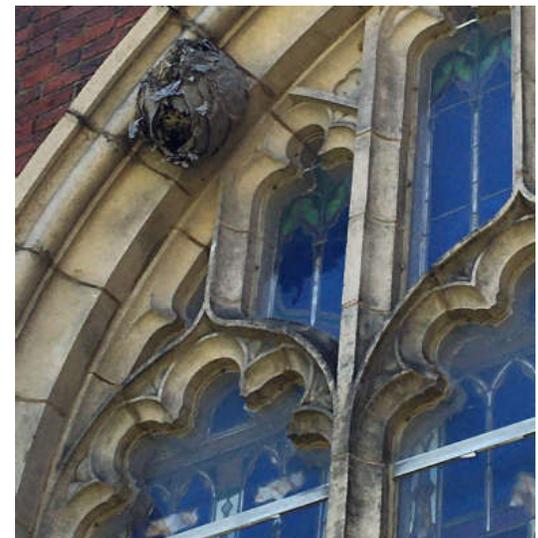
We noted several locations of wasps/insect nests at the building face – a common occurrence for all buildings. We recommend you maintain a pest control agency to regularly inspect and/or treat for insect and rodent infestations.

Fig 142 - Wasps nest at window surround

*Hire a pest control company to perform inspections .....  
 .....Annual maintenance [P]  
 Provide bird control spikes at the Belfry (allowance).....\$8,400 [P]  
 Abate pipe insulation if found to be asbestos-containing (allowance) .....  
 .....\$7,300 [E]*

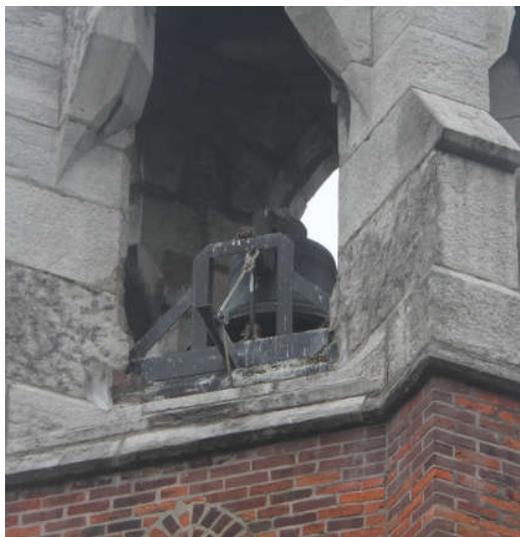
We also observed bird droppings at the bell within the Belfry tower. Bird droppings are considered hazardous materials and require careful removal due to their caustic nature. Netting of the Belfry openings is an option to keep out birds from the Belfry, but has impacts on the historic character of an important feature of the Church. Bird control spikes or wires are an option to provide at the Belfry openings; we included a budget for bird control in our estimate.

Fig 143 - Bird droppings in Belfry

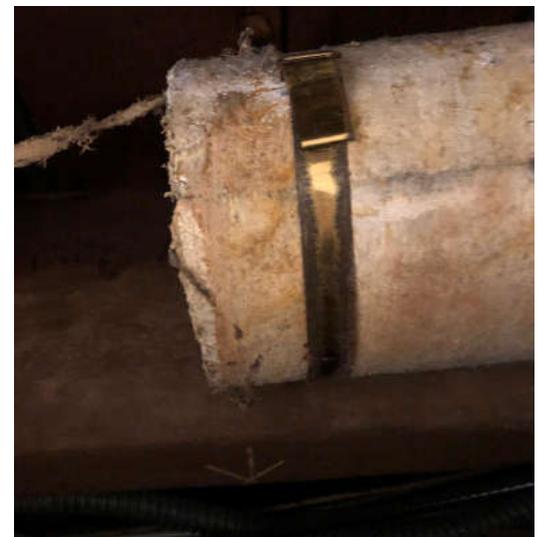
Aside from the tile flooring, we observed pipe insulation suspect to contain asbestos. If visible, this should be surveyed and abated. *Attachment 14* is a reference for determining which building materials are suspect to contain asbestos.

Fig 144 - Potential asbestos pipe insulation

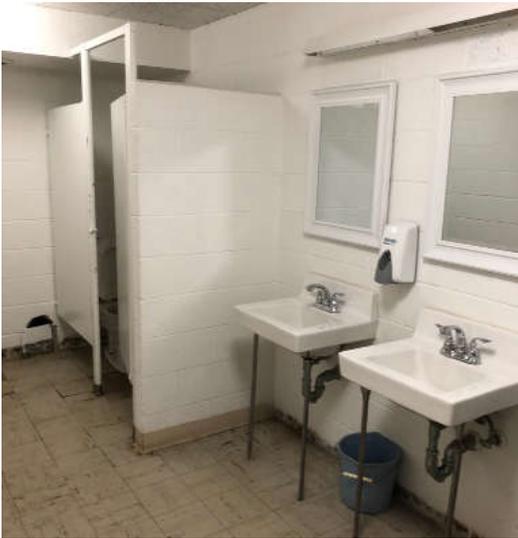
We noted dated plumbing fixtures and suggest when you undertake an accessibility project that accessibility-compliant and water-saving fixtures replace existing.

Fig 145 - Restroom fixtures

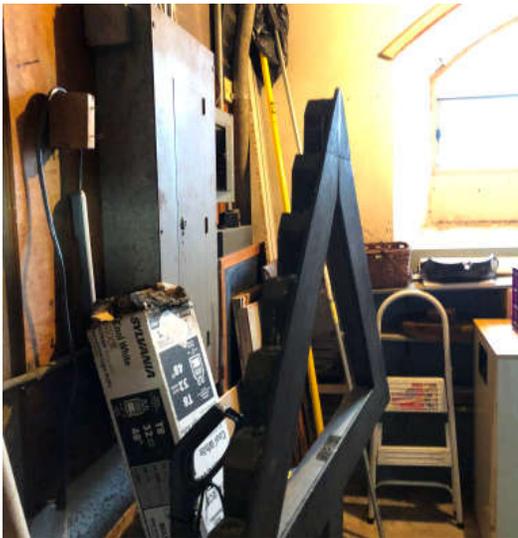
We observed that the Lower Hall mechanical space and stage area were used for storage. We recommend all mechanical and electrical rooms be cleared of storage of miscellaneous items to ensure proper clearances to equipment. The stage does not appear to be used, but if regularly used for occupancy, we recommend the storage materials be moved to an alternate location.

Fig 146 - Storage in mechanical space

*Clear mechanical and electrical spaces of storage to allow for equipment access  
.....Staff [E]*

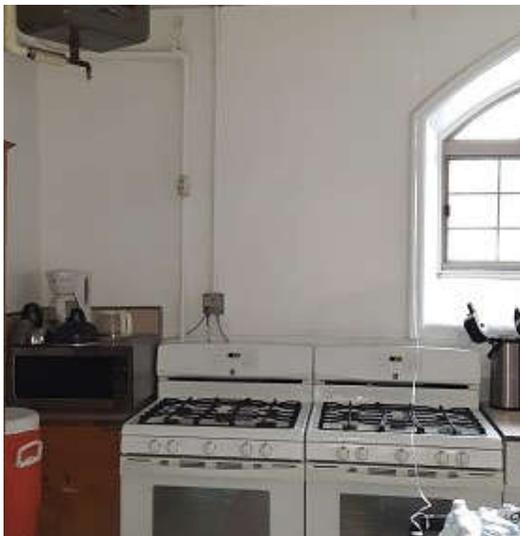
Fig 152 - Ranges with No Exhaust Unit Heater (above left)

| <i>Install residential hoods with fire suppression over ranges in Kitchen .....</i> | <i>.....\$18,000 [E]</i> |

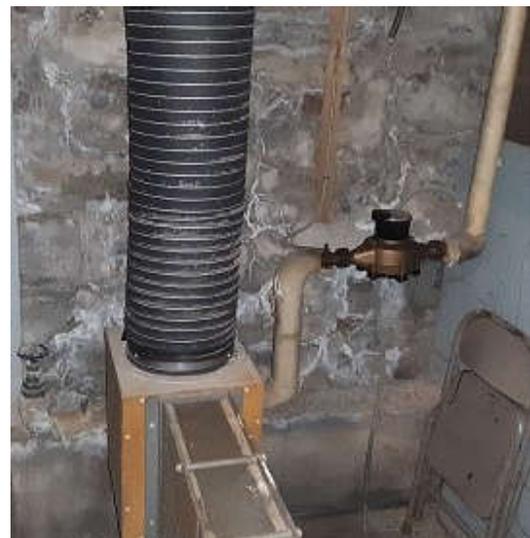
The building has a 1" water service located in the church south service room. There is no backflow preventer.

Fig 154 - Water Service

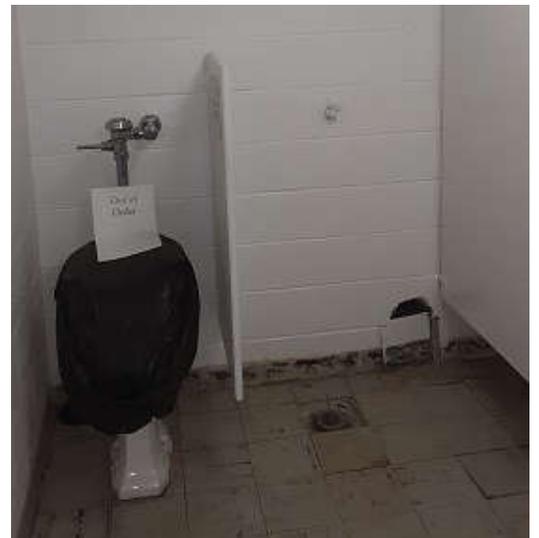
Fig 156 - Men's Room - Urinals

- Replace two urinals in Men's Restroom (basement) .....\$5,000 [E]*
- Provide proper vent in kitchen sink (Lower Hall, Church basement) .....\$250 [E]*

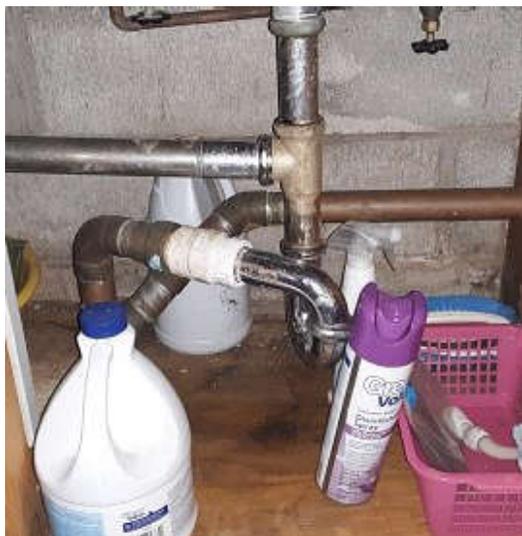
Fig 157 - Kitchen Sink Waste Piping

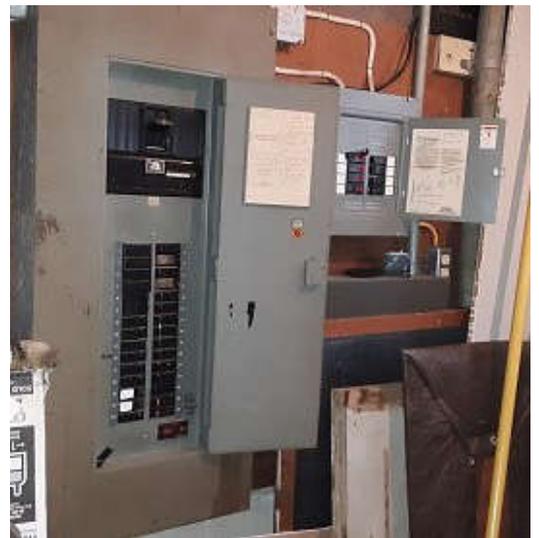
Fig 158 - Electric Service Main Distribution

The main distribution panelboard is labeled 200A, 208V with a 225A main circuit breaker. It is relatively old.  
 Sub-panelboard – 60A, loadcenter relatively new.  
 Boiler Room Panelboard – 100A older  
 Church 1st floor Panelboard – 100A older

Panelboards - The replacement/rebuilding of the panelboards should be considered due to age (greater than 50 years). This includes the main panelboard, boiler room panelboard, and church first floor panelboard. Many of the branch circuit breakers may have been replaced. Minimally all the circuit breakers can be tested.

- If none, install carbon monoxide alarm in kitchen (Lower Hall, Church basement) .....\$ 50 [E]*
- Install emergency lighting in exit pathways. Replace exit signs with LED fixtures .....\$ 2,500 [E]*
- Install heat detector in Kitchen (Lower Hall, Church basement) .....\$ 1,500 [E]*
- Test circuit breakers or replace panelboards .....\$ 15,000 [E]*
- Replace broken exterior light fixtures.....\$ 500 [E]*
- General: Continue replacing lamps with LED replacement lamps .....Annual maintenance [P]*

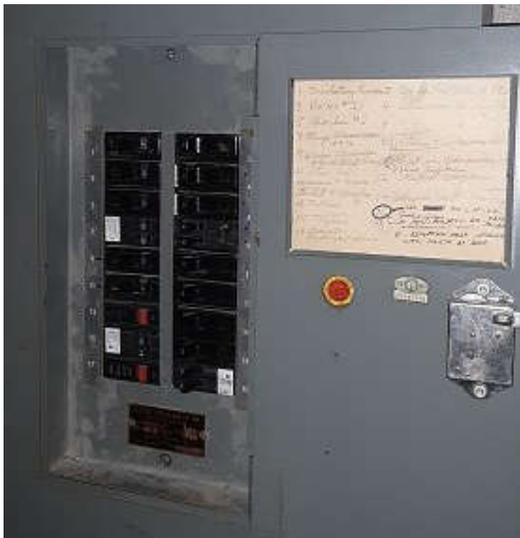
Fig 159 - Boiler Room Panelboard

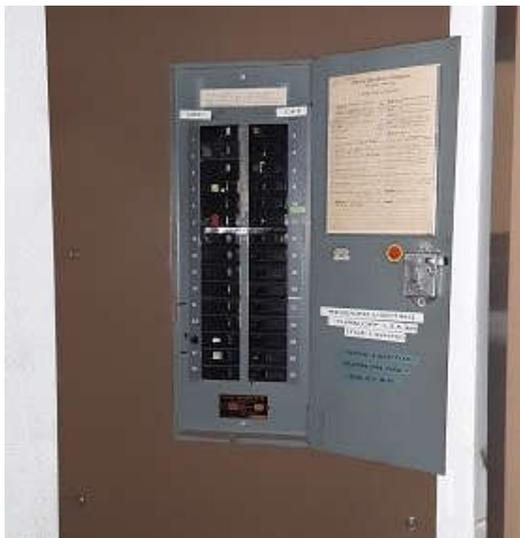
Fig 160 - Church Panelboard

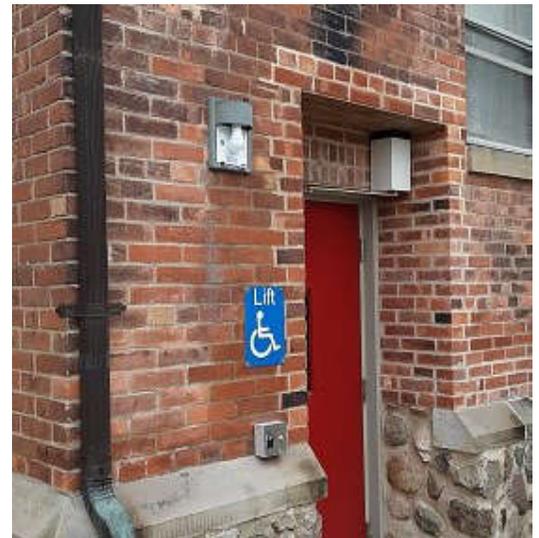
The exterior lights are generally incandescent in varying condition. There is a HID flood light for the parking lot. The wall light at the lift exterior door is missing a lens.

Fig 163 - Exterior Light at Lift

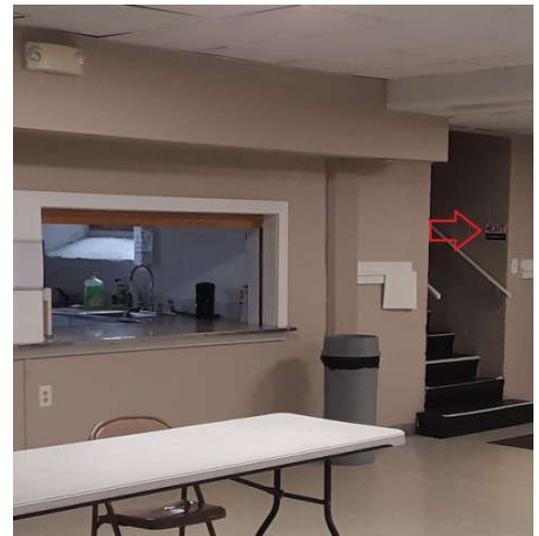
The building has some emergency lighting. There are some exit signs but they are not lit.

Any exit signs that are not lit should be replaced with LED exit signs with back-up battery.

Fig 164 - Typical Exit Sign
